# **Decommissioning of DR 1**

## **Final report**

**DD-18(EN) rev.1**  
**January 2006**  
**J.nr.** DD-2004-412-3

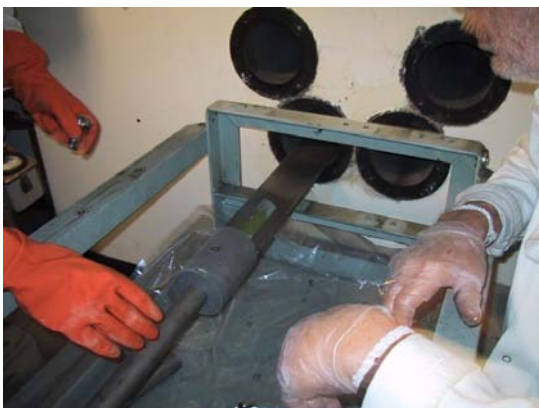
*Figure 5 Control rod being pulled out*

Two of the four control rods had been taken out during the characterisation project and the dose rate at a distance of 10 cm measured to 60  $\mu\text{Sv/h}$  in the western end, which was the one that had received the highest neutron exposure. Therefore, brief direct contact with the rods did not present any problem, and they were just taken out by hand and transferred to plastic bags and subsequently placed in a container made for the purpose. Figure 5 to Figure 8 show some steps in the removal of the control rods. Radiation doses incurred to the operators were small.

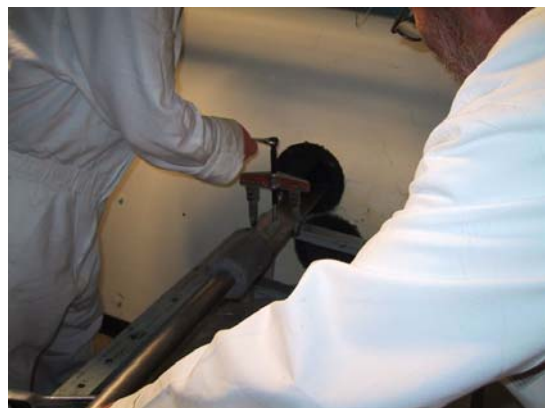
*Figure 6 Removing the pin connecting the control blade to the guide rod*

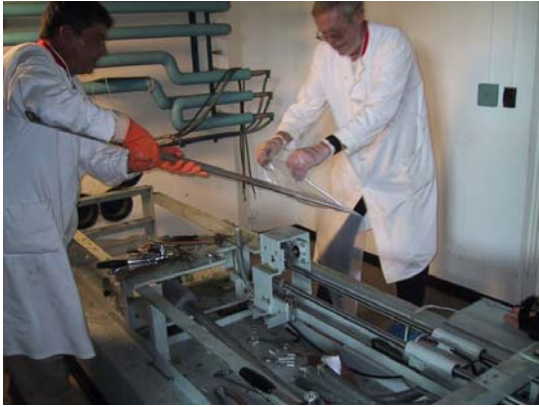
*Figure 7 Transferring a control blade to a plastic bag*

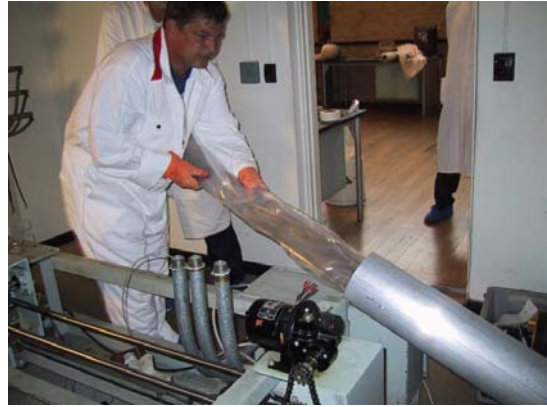
*Figure 8 Transferring a control blade to the special container*

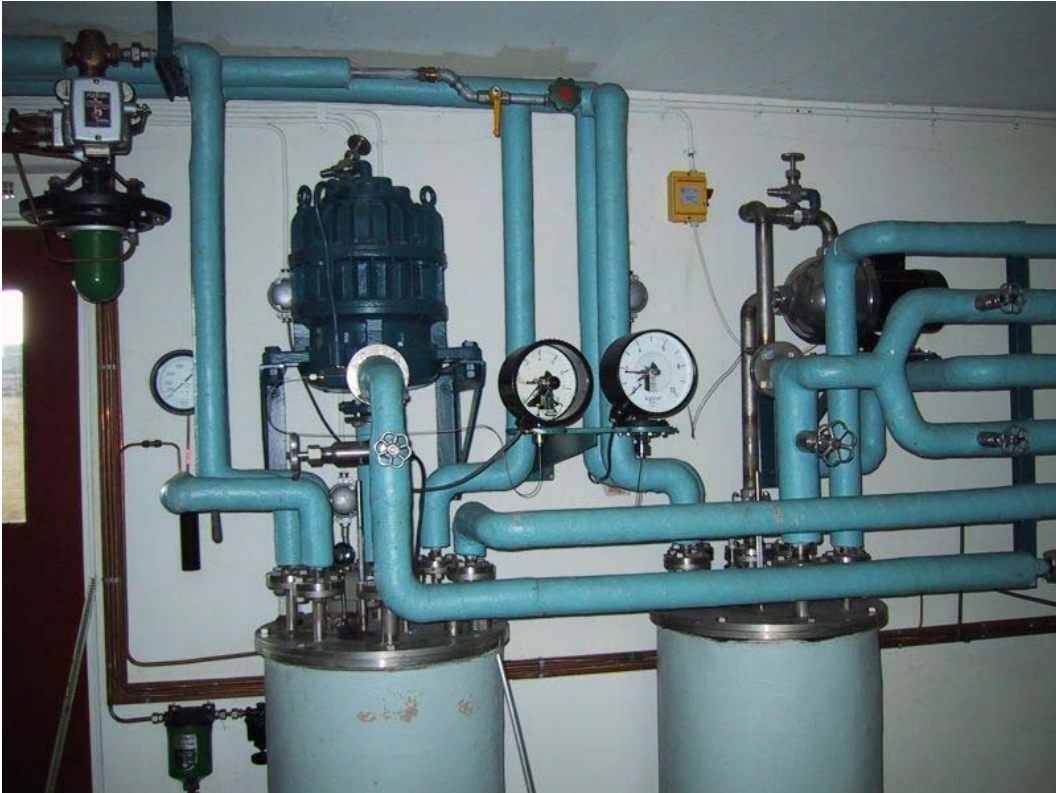
After dismantling smear tests were taken from the primary sides of the heat exchangers and – to some surprise – traces were found of  $^{60}\text{Co}$  in the samples from the core cooling system. However, the contamination seemed to be rather loose and attempts will be made to clean the component for clearance. Due to the somewhat complicated geometry of the component clearance can not be achieved on the basis of ordinary contamination measurements but  $\gamma$ -spectrometric analyses have to be done in the clearance laboratory.

*Figure 9 Heat exchangers and cooling pumps. The system to the left belongs to the core cooling circuit, the one to the right to the recombiner cooling circuits.*

Prior to the dismantling the heat exchangers and piping were emptied for water. The water was collected in drums and samples were taken for  $\gamma$ -spectrometric analyses of possible content of radionuclides. No measurable amounts of radionuclides were found.

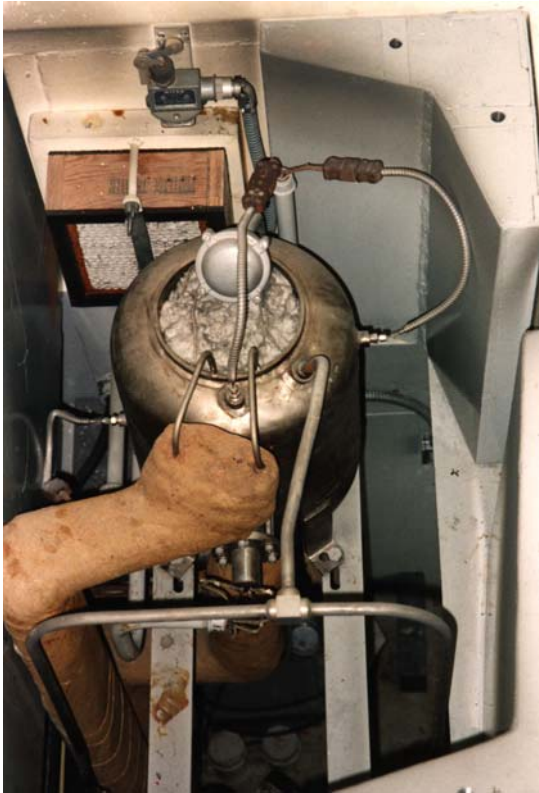
Figure 10 The recombiner seen from above

Figure 10 shows the recombiner seen from above. Its outside diameter is 270 mm and the height  $\sim$ 500 mm. The weight is about 30 kg. At the bottom a flange connected it to the pipe leading to the core vessel, cf. Figure 11. The recombiner rested on four feet that were bolted to two beams below, as can be seen in Figure 10. A number of cooling pipes and cables for measuring equipment and power supply were attached to the recombiner.

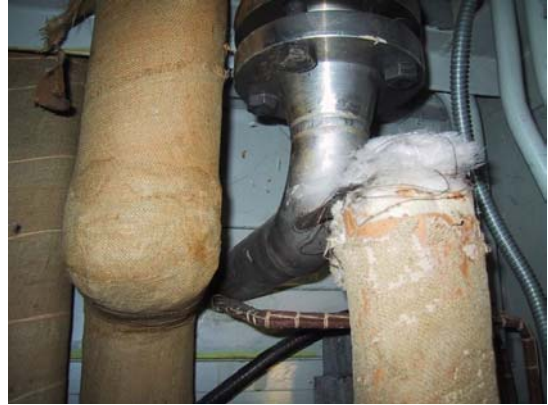
Figure 11 Flange at the bottom of the recombiner

In the initial planning it was contemplated to cut the connecting pipe between the recombiner and the core vessel by means of a hydraulic tool, which DD already had. The tool is able to seal the two ends cut away by pressing them before cutting in the middle. In this way the risk of releasing possible contamination would be minimised. However, test cuts on similar piping showed that the tool probably would not be powerful enough to press and cut the 2 $\frac{3}{8}$ " stainless steel pipe. Since a larger tool would be very expensive and since radiation levels were moderate, it was considered justifiable to disconnect the recombiner by opening the flange at the bottom and quickly replacing the two open ends with blind flanges. This operation was carried out without any particular problems; the bolts and nuts came apart easily. In order to reduce doses to the technicians, extension-shafts were used for the spanners.

No loose contamination escaped during the dismantling; but smear tests confirmed that there was a layer containing  $^{137}\text{Cs}$  at the inside of the pipe and flange.

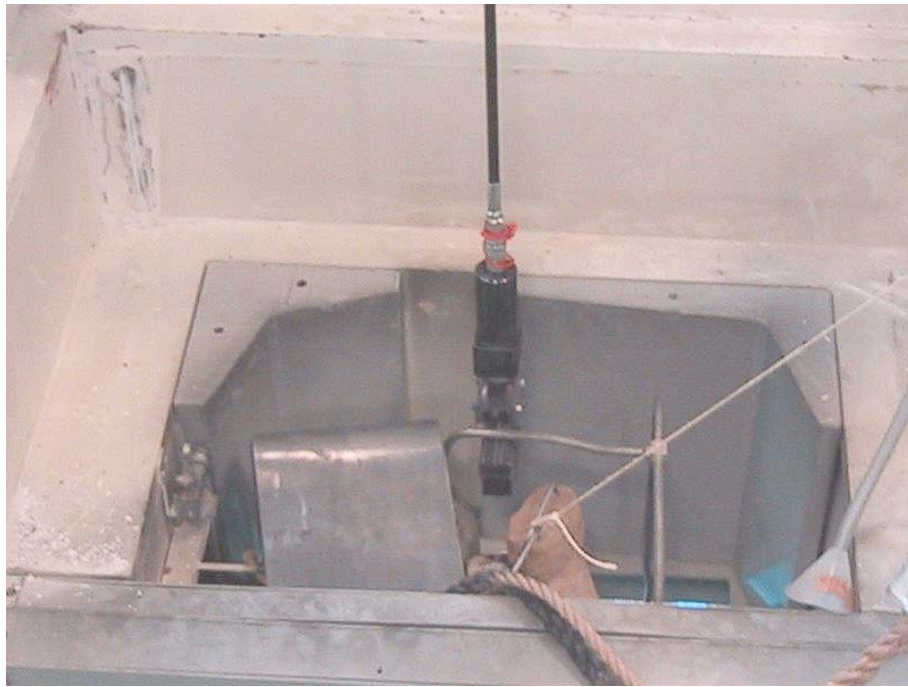
*Figure 12 Hydraulic cutting tool in action*

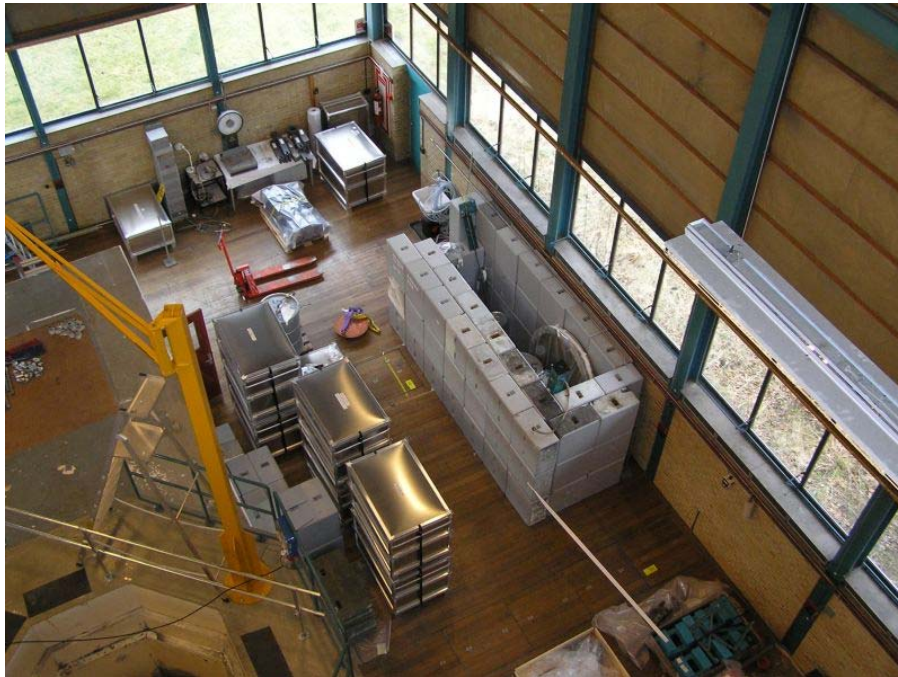
The recombiner was lifted out and placed in a shielded drum that was transferred to a shielded cell made of concrete blocks in the southern part of the reactor hall, cf. Figure 14. The lifting gear seen in Figure 13 was disposed of together with the recombiner in order to save doses to the personnel.

*Figure 14 Photo taken from the overhead travelling crane.  
The shielded cell is seen in the centre of the photo.*

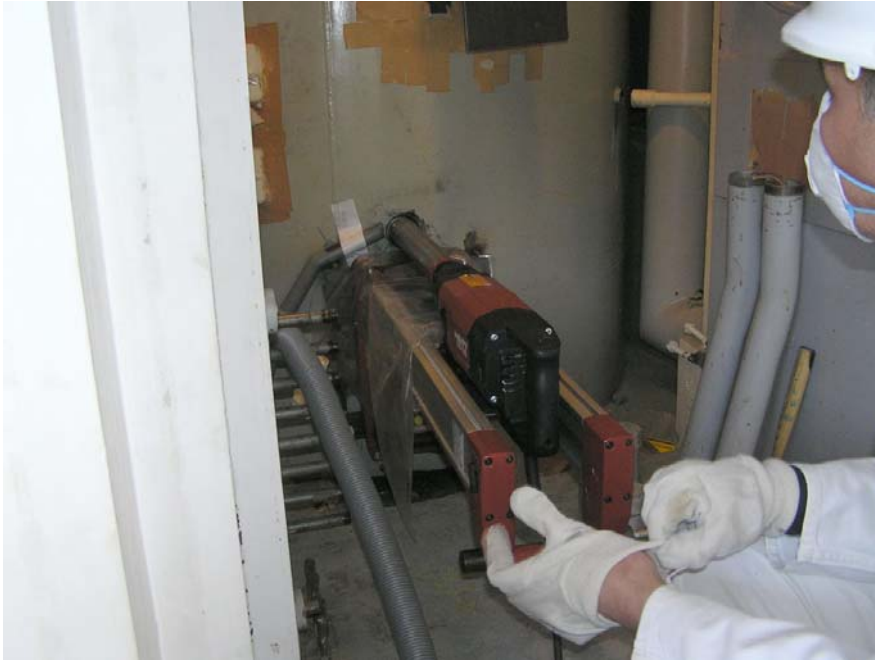
At the end alternative 6 was selected. The drilling could be carried out by means of already existing equipment. A frame was welded to the wall of the reflector tank for mounting of the drilling machine. Figure 16 shows the set-up at the start of the drilling. As far as possible, the graphite dust generated was caught at the entrance hole by a vacuum cleaner; but some (slightly active) dust found its way to the floor outside and caused some contamination. Nevertheless, the operation was considered very successful; the drill followed the correct direction and the drainpipe was cut exactly where it was supposed to be cut.

*Figure 16 Drilling a core around the drainpipe*

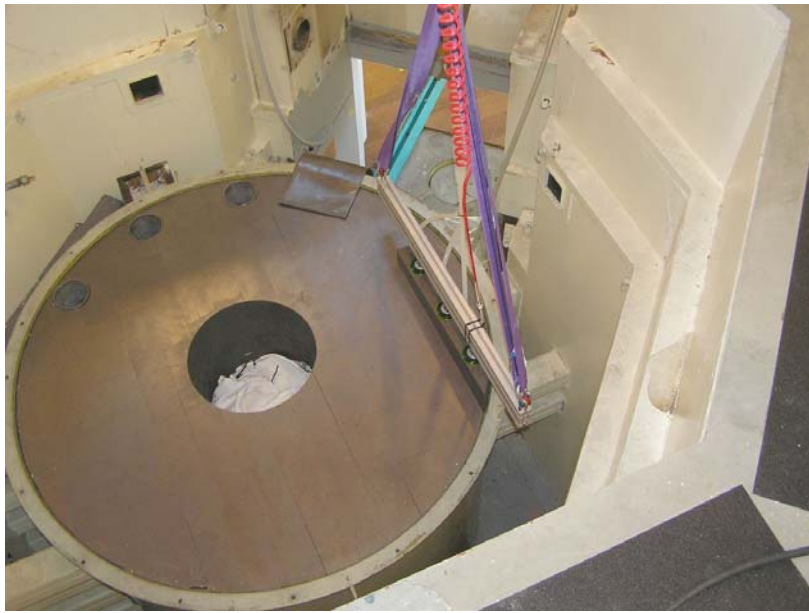
Two technicians operated the system: one stood at the top of the biological shield and manoeuvred the beam with suction pads into position by means of a long rod, and the other operated the air supply for the suction pads and the swinging crane used for lifting out the graphite elements and transferring them to the roof of the control rod house, cf. Figure 18 and Figure 19. Here each element was weighed, measured and registered. This kept two other people busy in addition to a health physics technician who surveyed the working environment and performed measurements of the radiation from each element. Finally the graphite elements were transferred to pallet containers, which were later transferred to the "Centralvejslageret". The meticulous registration was carried out with a view to being able to sort the elements into active and potentially non-active that could be cleared. As it turned out, there seemed to be activity levels above the perceived clearance levels in most of the elements (at the time of taking out the elements clearance levels had not yet been issued by the authorities). In order to reduce radiation levels during the operation bags with lead pellets were used to shield the core vessel, cf. Figure 17.

*Figure 17 Beam with suction pads*

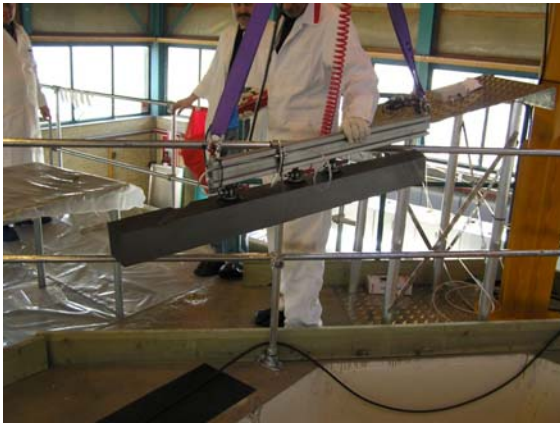
*Figure 18 One of the longest stringers*

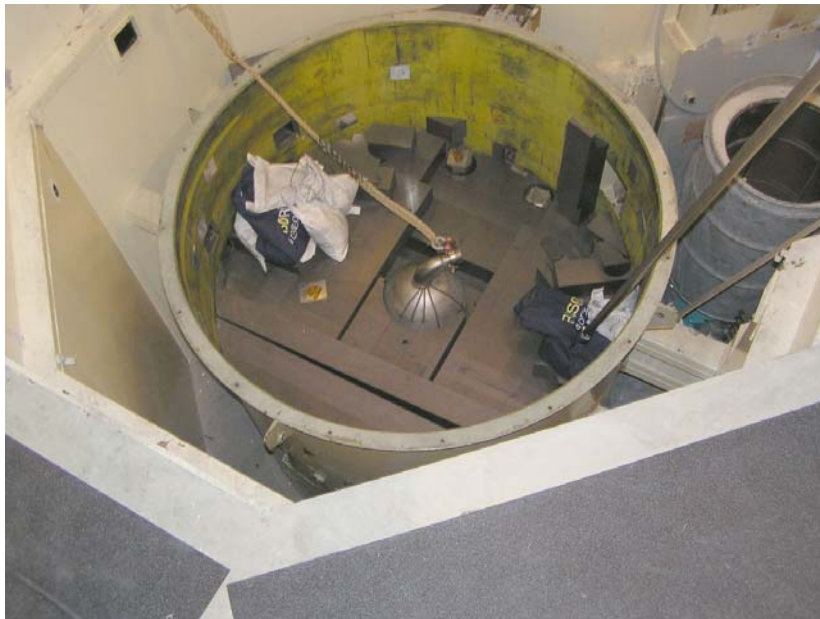
After the removal of seven layers of graphite and parts of the eighth layer the 2 $\frac{3}{8}$ " pipe could be cut loose from the core vessel and a mounting could be fixed for lifting out the core vessel. After the removal of another layer the vessel could be lifted out and transferred to a shielded waste drum, cf. Figure 20. The weight of the core vessel was about 5 kg. The radiation level at the surface of the vessel was about 4 mSv/h.

*Figure 20 The core vessel ready to be lifted out*

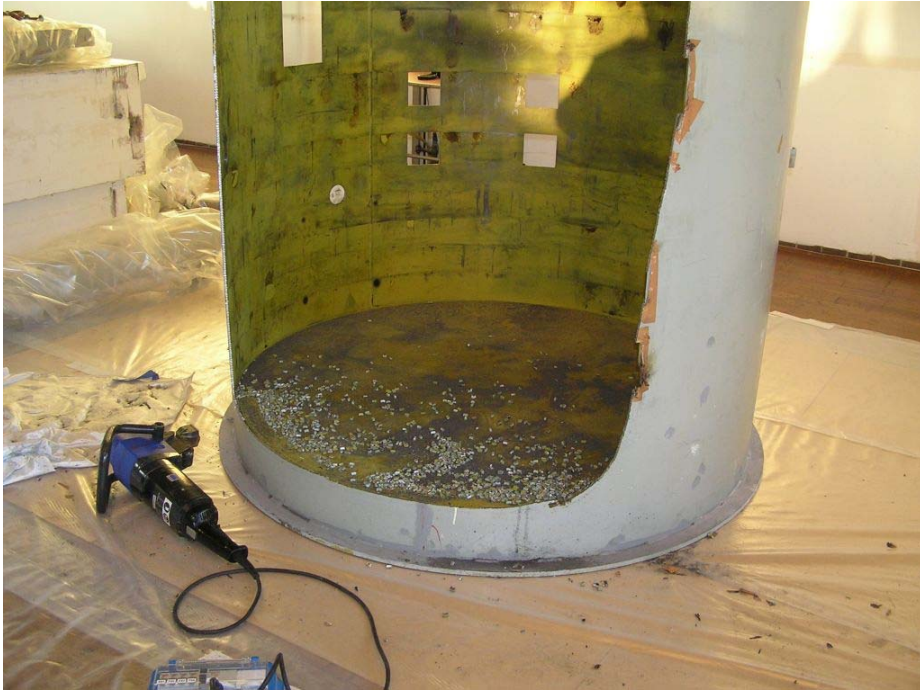
*Figure 21 The nibbler and the half-cut reflector tank*

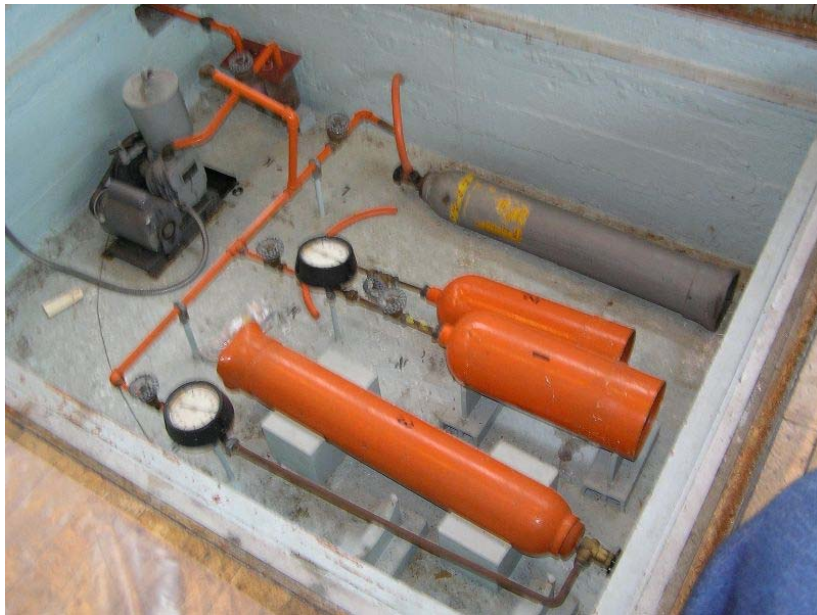
The fission gas station served to store fission gases produced in the reactor in order for the pressure in the reactor not to increase above the limit of 5 psi. The fission gas station, shown in Figure 22, was located in a shielded pit below the floor in the northern side of the reactor hall, cf. Figure 4. Two storage tanks were in operation at a time. Once a year gases were pumped from the reactor to the storage tanks. The following year the gases in the tanks were emptied via a carbon filter.

*Figure 22 The fission gas station*

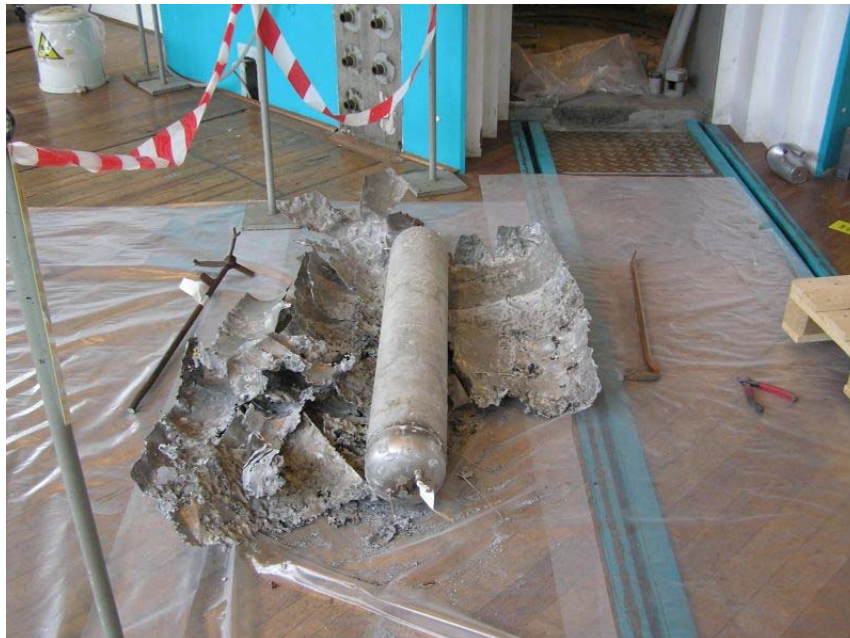
The two connecting pipes could easily be cut by a wire cutter, and then the tank could be lifted out. As can be seen from Figure 23 the cadmium wrapping had disintegrated rather much and had to be handled with care due to its chemical toxicity.

*Figure 23 The Fuel Drain Tank*

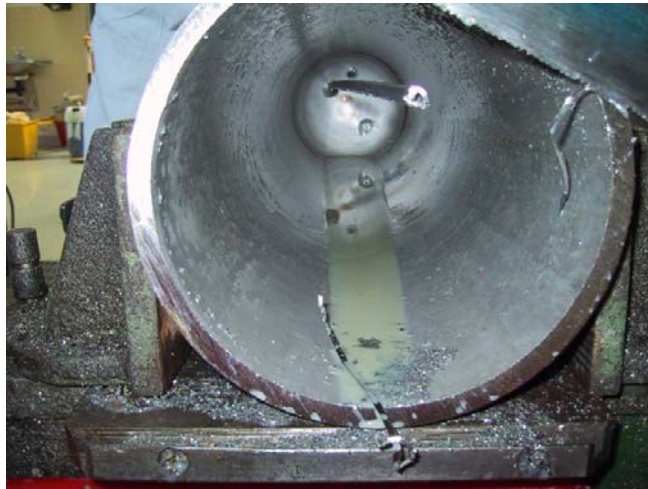
taminating it. As can be seen from Figure 24 the inner surface appears quite clean; the fluid that can be seen is cutting fluid. The tank will be decontaminated in Danish Decommissioning's new decontamination facility once this facility is operational. It is expected that the tank can be cleared as non-radioactive waste after decontamination.

*Figure 24 The Fuel Drain Tank cut apart*

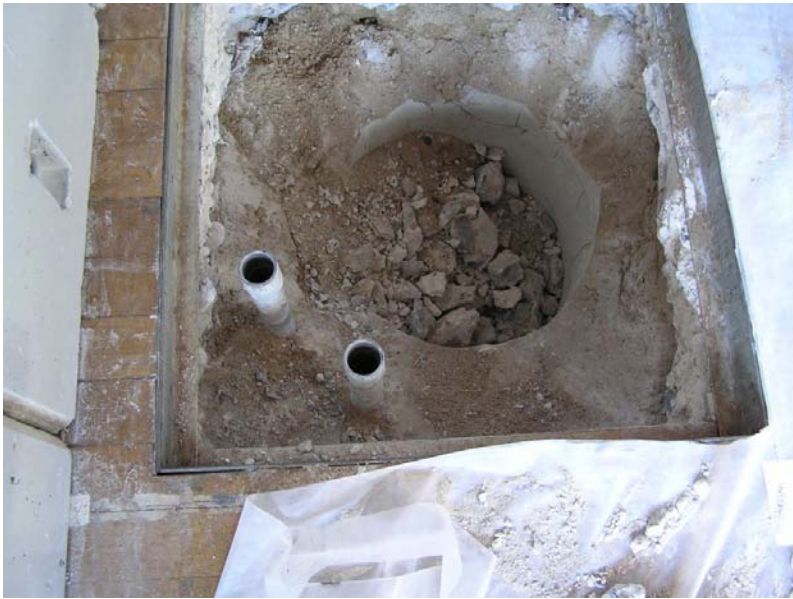
Due to a leak in one of the bottles with samples of the fuel solution – and probably to other spillages in the course of time – there was some contamination at the bottom of the well and down the inner sides. The concrete at the sides and in the bottom was chiselled away until no further contamination could be detected with the hand-held contamination monitors (CoMo 170/300 and Eberline E 600). The concrete thus chiselled away was disposed of as radioactive waste.

Figure 25 The well under the floor being demolished

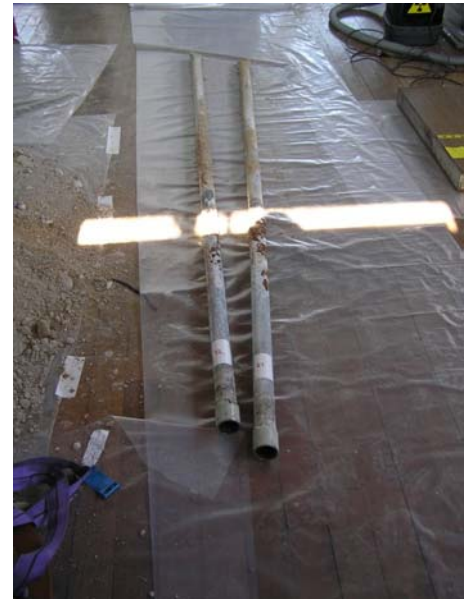
The two 2" steel pipes could be taken up fairly easily. Smear tests revealed some contamination in one of the pipes, but it is expected that they can both be cleared as non-radioactive waste.

Figure 26 The two storage pipes

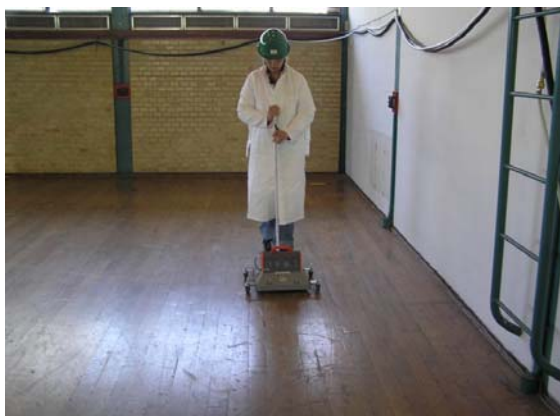
When everything had been removed the floor was cleaned and surveyed for contamination with a floor monitor, as shown in Figure 27. A number of contaminated spots were identified and marked with yellow paint, such as those shown in Figure 28, which were located just below the Fuel Mix Bowl. Here radioactive fuel samples, which were taken annually for analysis, had been returned to the system – and apparently sometimes with a shaking hand. Also other contaminated spots could be related to the handling of samples of the fuel solution. Some of the contaminated areas were removed by cutting away the affected parts

Figure 27 Survey of wooden floor

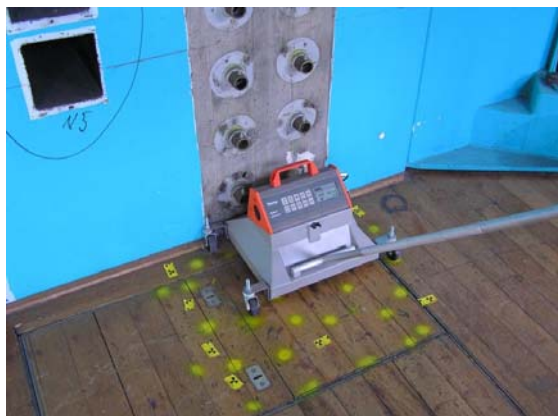
Figure 28 Contaminated area under the Fuel Mix Bowl

of the floor. Other parts were covered with plastic and wooden plates, since we had decided to keep most of the floor in place during the demolition work; only the floor in a distance of about 1 metre from the reactor block was taken up in order to allow trays for collecting the cutting water to be placed as low as possible on the block, cf. section 5.9.2..

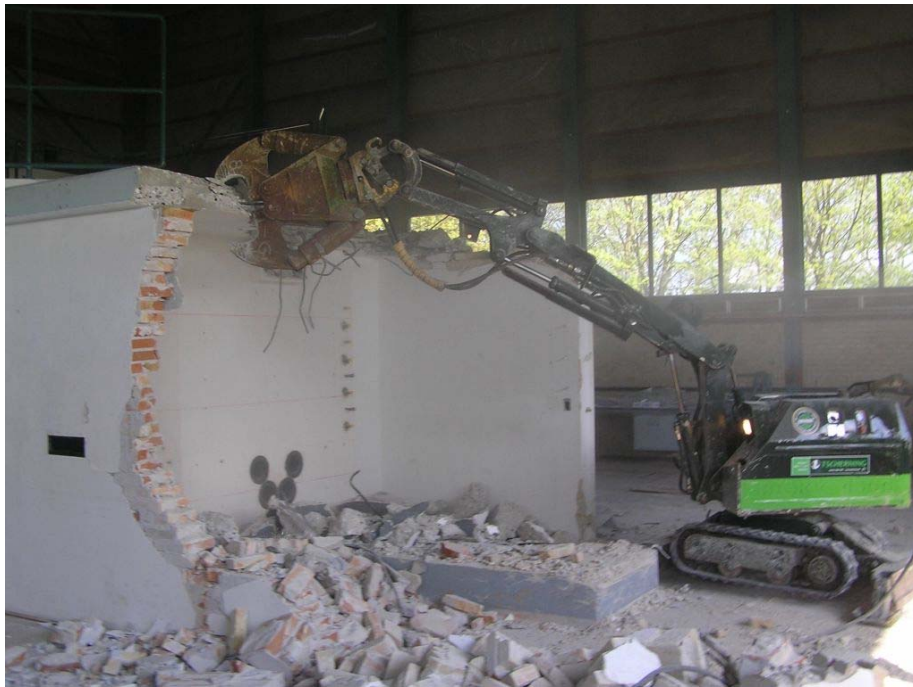
The roof of the control rod house consisted of a number of concrete slabs that could be lifted off and taken out in one piece. The walls, which were ordinary brick walls, were broken down by a demolition robot, as shown in Figure 29. The roof was disposed of as ordinary concrete waste at a waste dump outside the Risø area, and the rubble from the brick walls was stored in two containers, waiting for measurement to be carried out later.

*Figure 29 Demolition of the control rod house*

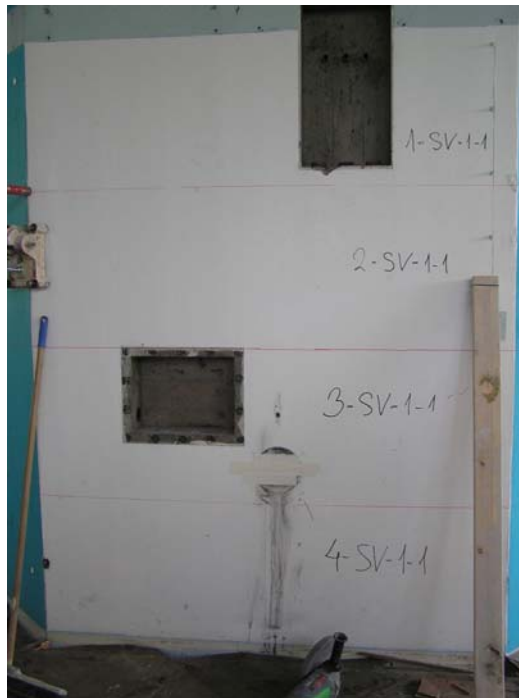
Figure 30 Horizontal cutting lines and block numbering on the south-western face

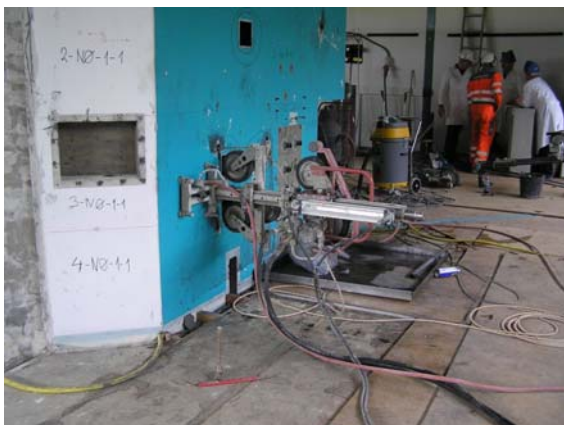
Figure 33 Cutting the four experimental channels on the northern face

The first cuts to be made were cutting away the two blocks of experimental channels from the southern and the northern face, respectively. These blocks were cut out and disposed of as radioactive waste altogether, even though some of the concrete and the outer parts of the steel channels might have been cleared. Figure 33 and Figure 34 show how the cut of the four channels on the northern face was made. Figure 34 also shows that the first cut thereafter was cutting away the concrete above the movable concrete "door" to the recombiner vault, in order to facilitate access to the reactor cave. The cutting technicians had to go in there in order to mount the wire for a new cut. Figure 35 and Figure 36 illustrate the drilling-out of individual experimental channels.

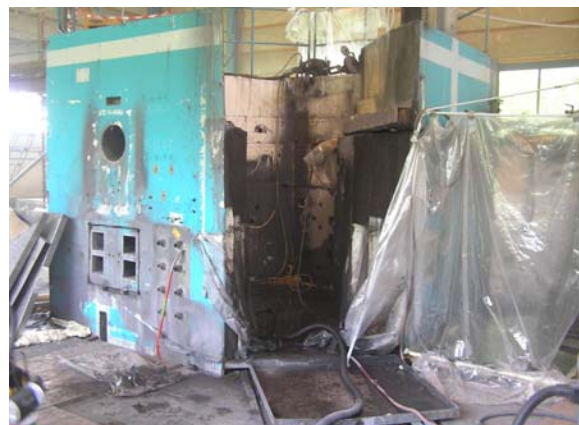
Figure 34 The block has been opened by cutting away the block above the "concrete door"

Similar to the experimental channels the concrete surrounding the valve arrangement, which can be seen in the foreground on the left hand side of the block in Figure 34, was cut out in one piece and stored as radioactive waste. Inside the concrete block are the pipes leading from the Fuel Mix Bowl, containing traces of fuel solution, and on the inner side of the block the steel parts closest to the reactor core were activated above the clearance levels.

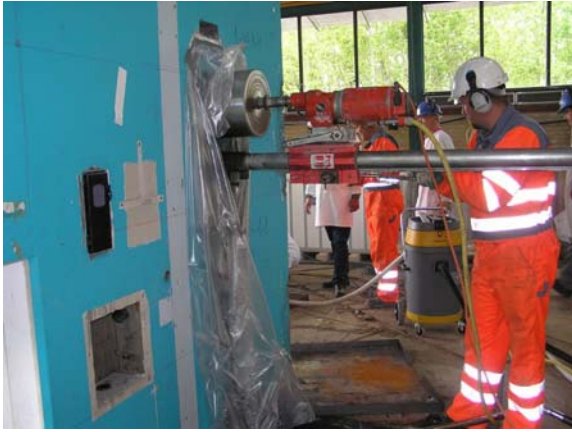
*Figure 35 Channel on the western face being drilled out*

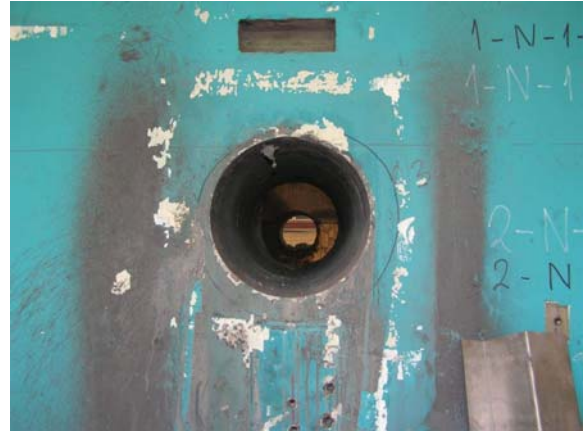
*Figure 36 A look through the upper channels on the northern and southern face*

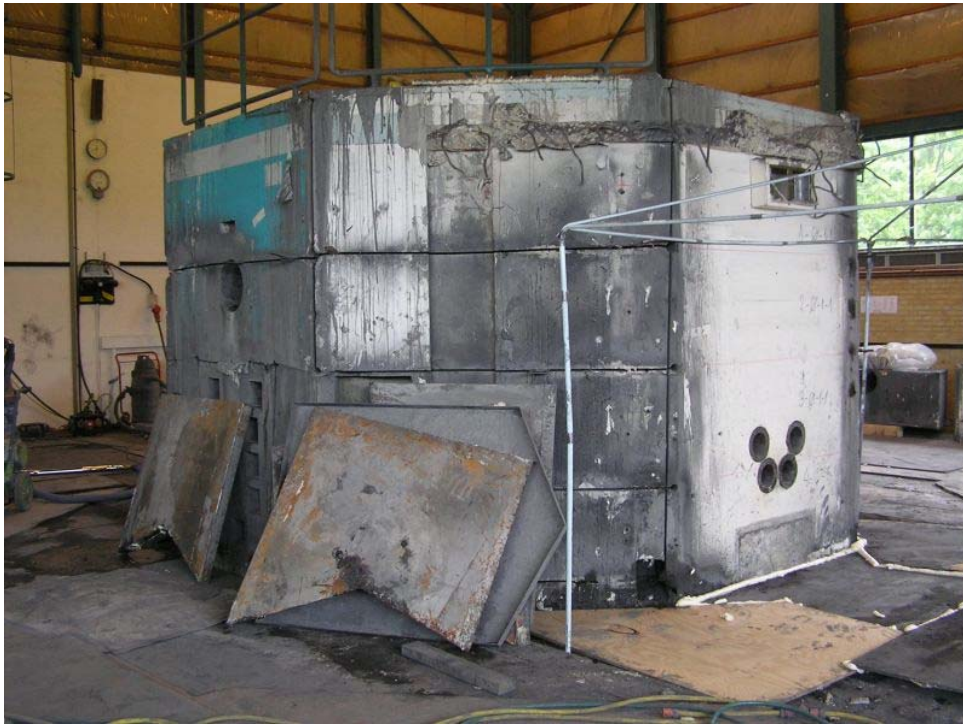
Thereafter all the vertical cuts in the corners of the octagonal block were made with the driving mechanism for the wire placed on top of the block, thus pulling the wire upwards while cutting. Subsequently, the horizontal cuts were made – often without removing the cut-loose blocks at once, as illustrated by Figure 37. Also shown in Figure 37 are some of the trays that were used for collecting the cutting water. The trays were made to fit to the bottom of the walls, and the gaps between tray and wall were sealed by means of foam. Reasons for not removing the blocks at once were the constrained space in the reactor hall and a wish from the contractor to get most of the wire cutting done before starting the cutting away of the inner, activated parts of the blocks, which was done by means of a circular saw, shown in Figure 38. This saw was placed in the western end of the reactor hall. Figure 39 shows a block after removal of the inner part that contained activity above the clearance levels.

*Figure 37 Vertical and horizontal cuts in the reactor block. In the foreground trays used for collecting cutting water.*

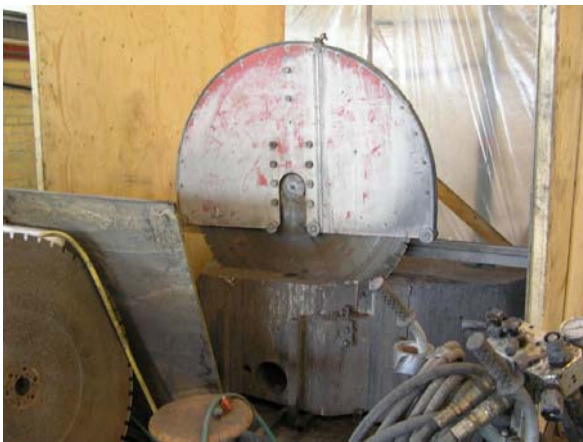
*Figure 38 Circular saw cutting away the activated inner slab*

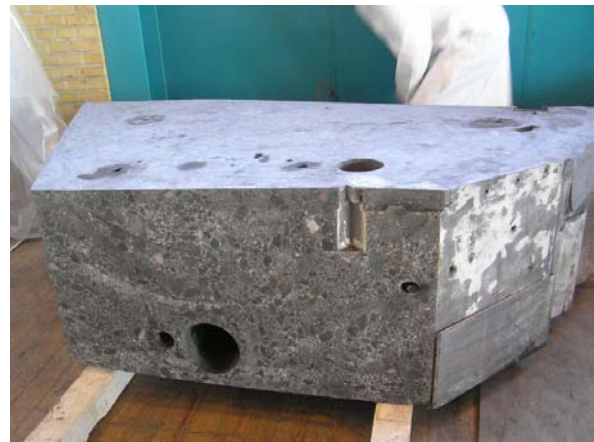
*Figure 39 Free-releasable block after removal of the activated slab*

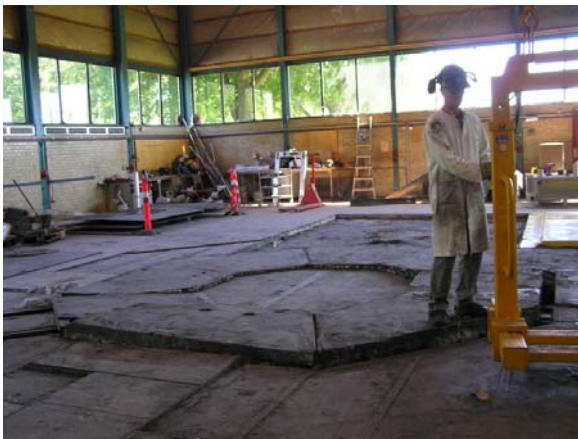
Figure 40 The foundation of the reactor block

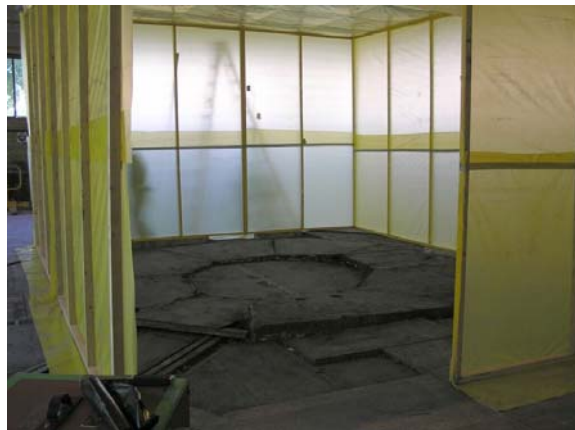
Figure 41 The tent being set up

Wire cutting could only be done until approximately 10 centimetres above the floor level. Thereafter a "Brokk" hydraulic demolition robot was used to chisel away the concrete. In order to prevent the dispersion of dust in the hall, a tent was set up for this operation. The tent was equipped with filtered ventilation, cf. Figure 42.

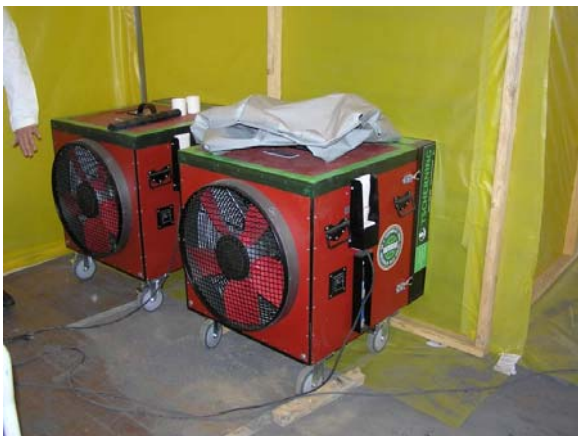
Figure 42 Ventilators with HEPA filters

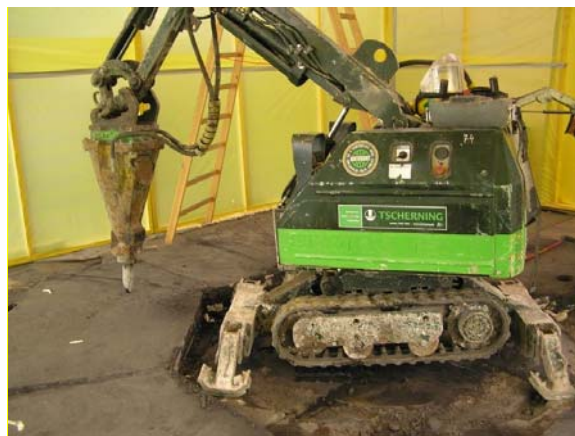
Figure 43 The Brokk demolition robot

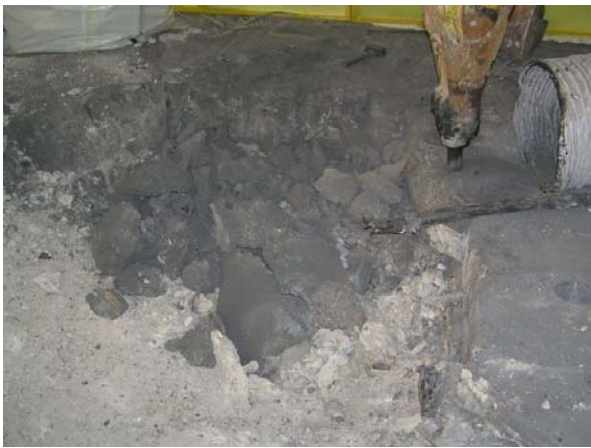
As can be seen from Figure 44, local extraction ventilation was set up close to the chisel. The excavated material was transferred to big bags, cf. Figure 45, which were subsequently stored as radioactive waste in an ISO container. Once the analyses of samples showed that the activity content in the remaining concrete was so low that there was a high probability for it to be cleared, all loose rubble was transferred to the big bags. The remaining concrete in the foundation of the biological shield was excavated as ordinary concrete waste, however, still subject to control before being cleared – every batch that was taken out by a "mini dumper" was scanned with a radiation monitor. The concrete was chiselled down to the same level as the surrounding foundation for the floor. The further handling of the concrete is described in chapter 7.

*Figure 44 The central parts below the reactor being excavated*

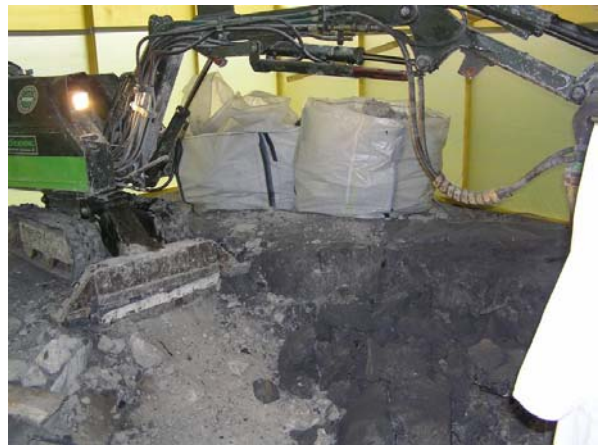
*Figure 45 The demolition robot in action. Two big bags with excavated material in the background*

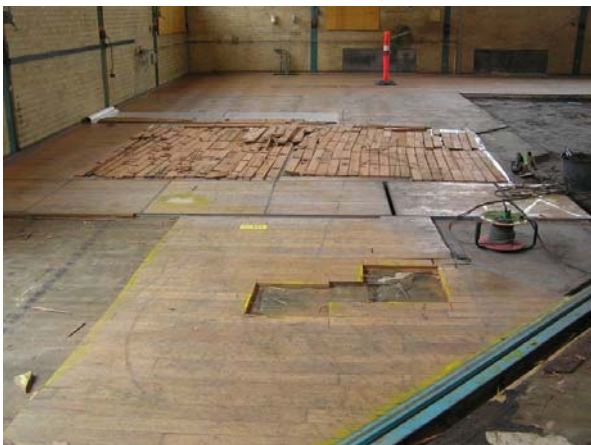
After completion of the demolition of the biological shield and the concrete below the reflector tank the wooden floor was removed. Prior to removal, however, the whole floor was surveyed once again with a floor monitor and contaminated spots were identified. The contamination probably originates from spillages of small amounts of fuel solution in connection with the annual sampling. The samples were tapped into plastic bottles, which were carried to the storage well, mentioned in section 5.6, and a number of contaminated spots were found on the way from the recombiner vault (where the tapping took place) to the storage well. The contaminated areas were marked with yellow paint and cut away and stored as radioactive waste before the rest of the wooden floor was taken up, cf. Figure 46.

*Figure 46 Contaminated parts have been cut out from the wooden floor. In the background a section of floor boards have been taken up.*

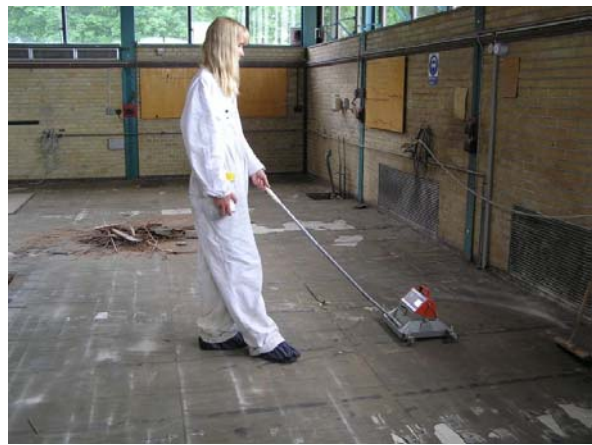
*Figure 47 Control measurement of the layer below the wooden floor.*

After the removal of the wooden floor, the sub floor (floor beams with concrete in between and a layer of tar cardboard on top) was checked with the floor monitor, see Figure 47.

Again, some contaminated spots were found, indicating that some of the spillages had been sufficiently big to penetrate the wooden floor boards. The contaminated parts were removed before the demolition contractor was allowed to break up the sub floor, see Figure 48 and Figure 49.

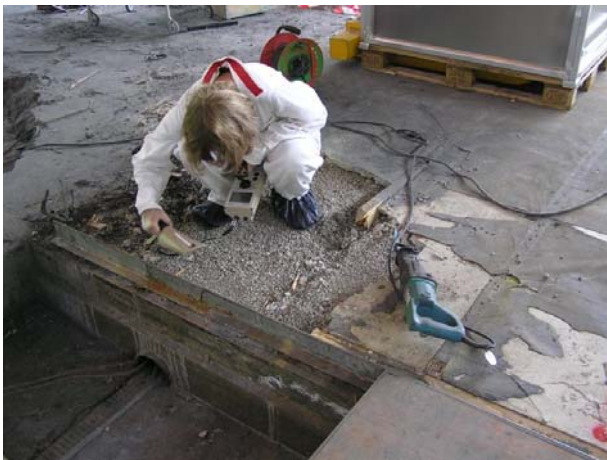
*Figure 48 Checking for contamination in the sub floor.*

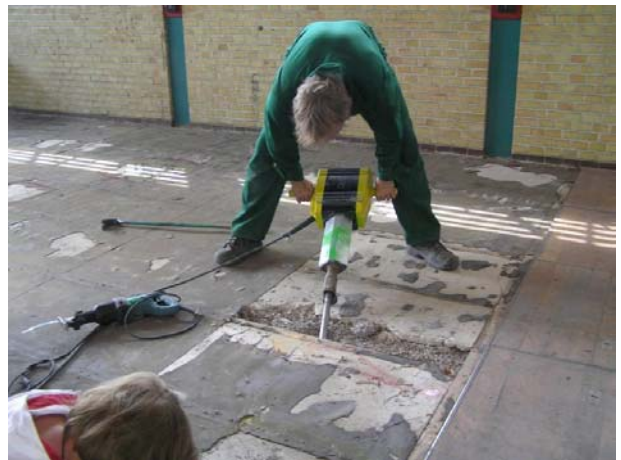
*Figure 49 Removal of a contaminated area of the sub floor.*

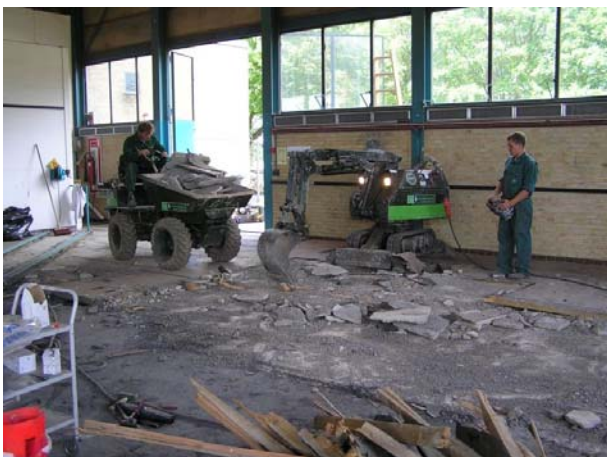
*Figure 50 Removal of the sub floor*

After the sub floor had been removed (Figure 50) the concrete base layer remained, and this was the condition in which it had been agreed with Risø National Laboratory to leave the floor. However, a further contamination check was carried out in the locations where contamination had been found in the sub floor. In some of these places contamination had, indeed, penetrated to the base layer, and concrete was chiselled out until the contamination was below the background level, Figure 51. Appendix 5 holds the original report in Danish of the measurement procedure during the removal of the floor.

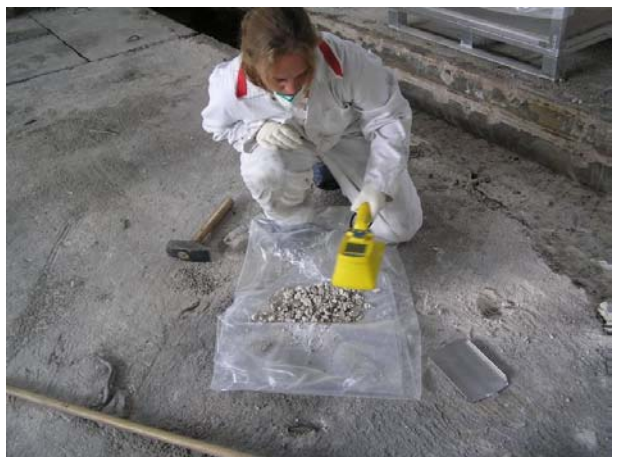
*Figure 51 Checking that material from the concrete base is free of contamination.*

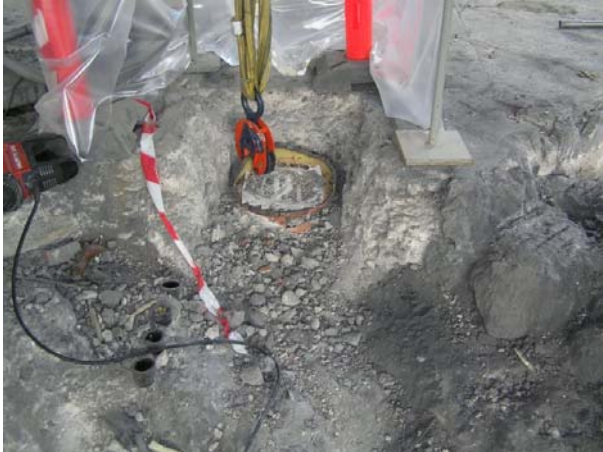
*Figure 52 The collar on top of the FDT pipe being lifted out*

After the concrete demolition had been completed, DD's own staff undertook to remove the top steel collar of the concrete pipe where the Fuel Drain Tank had been standing, including the two pieces of ¼" piping that went through the collar. One of the penetrations where the pipes went through can be seen at the lower part of the collar in *Figure 53*

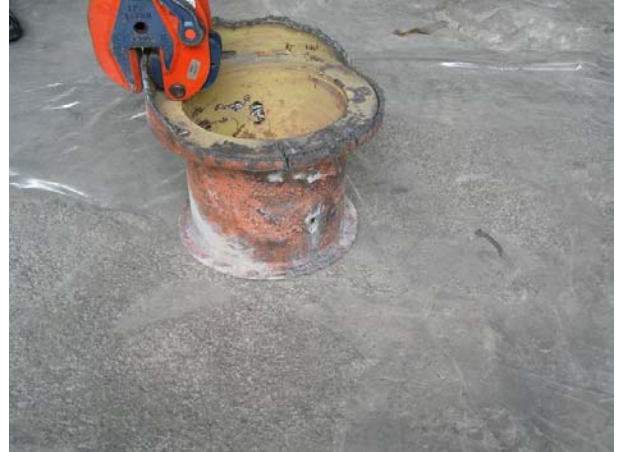
*Figure 53 The collar with penetrations for ¼" pipes*

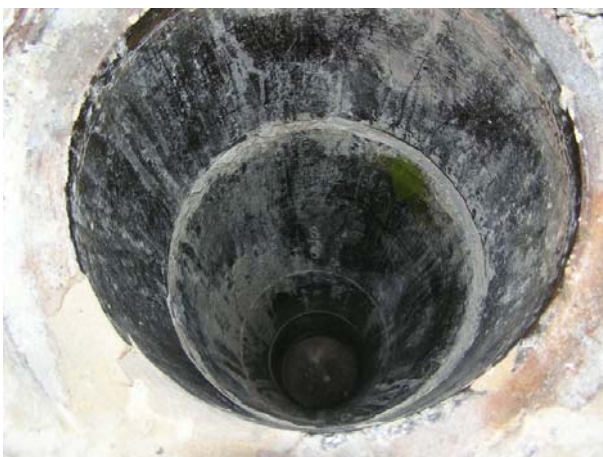
Unfortunately, some fuel solution must have been trapped in one of the ¼" pipes and have leaked out when attempts were made to pull the pipes out (prior to lifting out the steel collar), because the concrete pipe turned out afterwards to be contaminated, both along the sides and at the bottom. The pipe, which was 2.10 metres deep, is shown in *Figure 54*. It seemed to be composed of sections of glazed sewage piping. A number of methods to wipe off the contamination were attempted, ending up with the use of a drilling machine with steel brush mounted on a long shaft, as shown in *Figure 55*. By means of this tool the contamination could be removed so that the pipe could be cleared on the basis of measurements with a contamination monitor [1].

*Figure 54 The pipe where the Fuel Drain Tank had been standing*

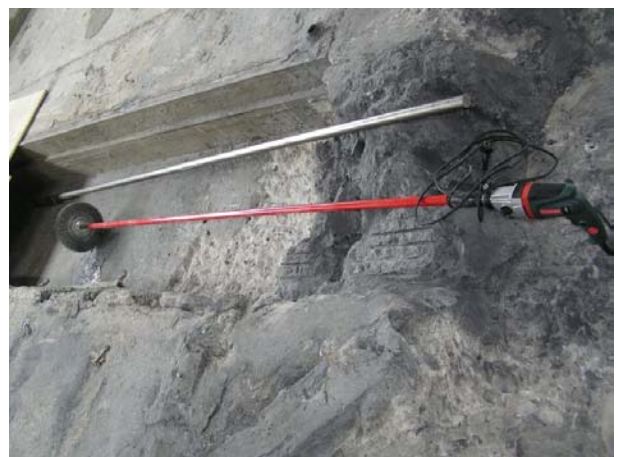
*Figure 55 Tool for decontaminating the pipe*

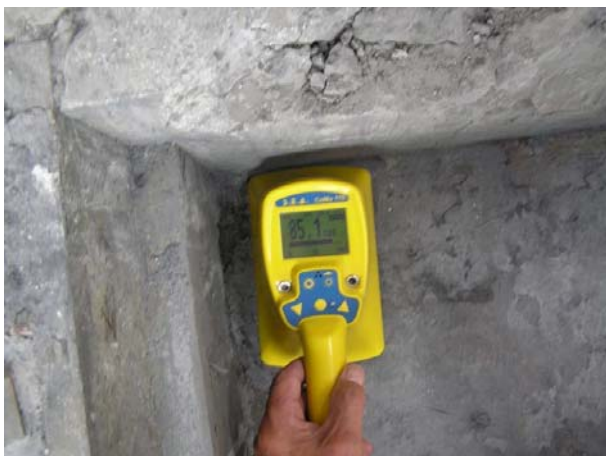
*Figure 56 Contamination measurement in the northern channel, below the Fuel Mix Bowl*

The three channels below the floor that extended from the reactor block to the South, West and North were checked for contamination by means of handheld contamination monitors. Since some contamination had already been detected on the floor above both the northern and the southern channel, it was not surprising to find contamination in the channels, too. In particular in the northern channel, just below the Fuel Mix Bowl, it had been expected that some fuel solution would be found. It was somewhat more surprising that contamination, mainly  $^{137}\text{Cs}$  could be detected on large parts of the bottom of the southern channel. In both cases the contamination had penetrated a few centimetres into the concrete and could be chiselled away (although it might have been an advantage having a "scabblor" for this task).

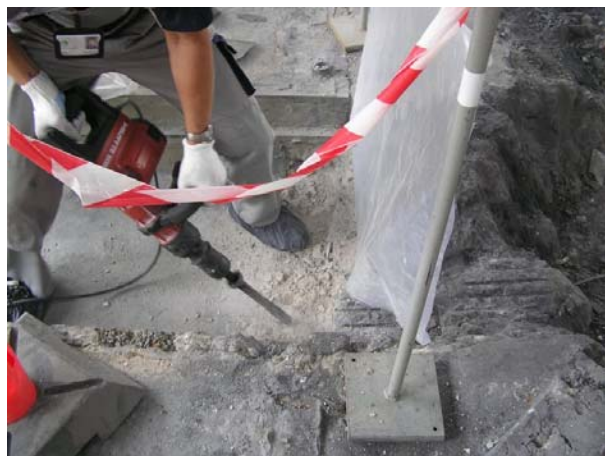
*Figure 57 Contaminated concrete being chiselled away (northern channel)*

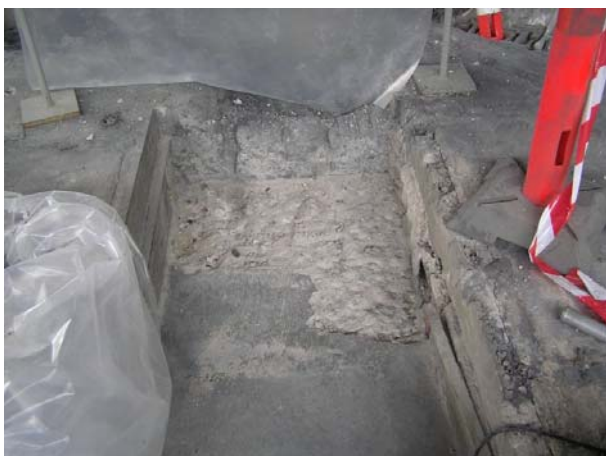
*Figure 58 Extent of contamination in the northern channel*

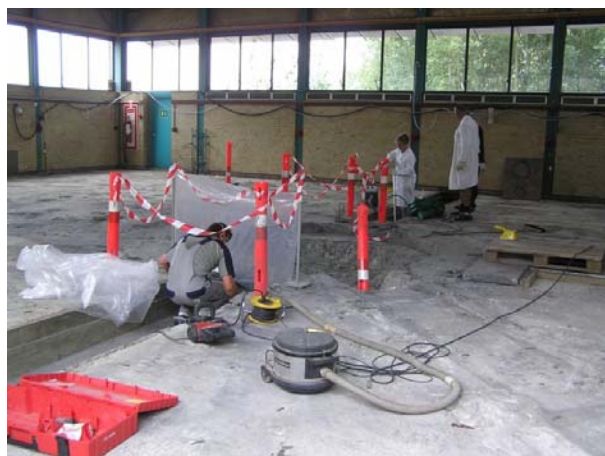
*Figure 59 Decontamination work going on in the northern and the southern channel*
