# **Decommissioning of DR 1**

## **Final report**

**DD-18(EN) rev.1**  
**January 2006**  
**J.nr.** DD-2004-412-3

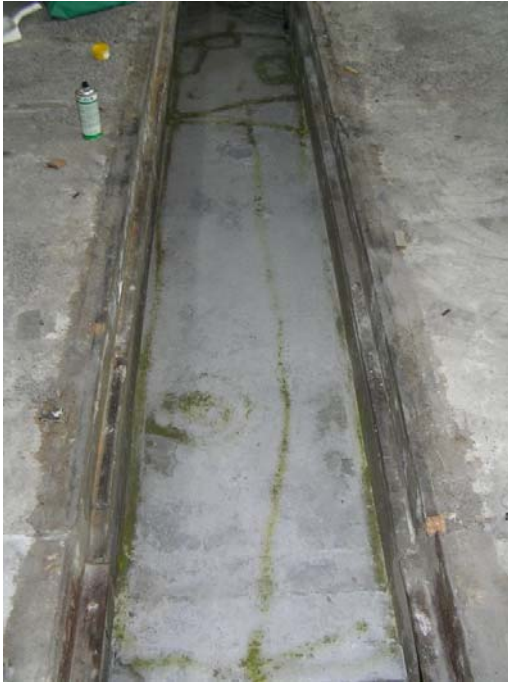
*Figure 60 Contaminated parts in the southern channel marked by yellow spray paint*

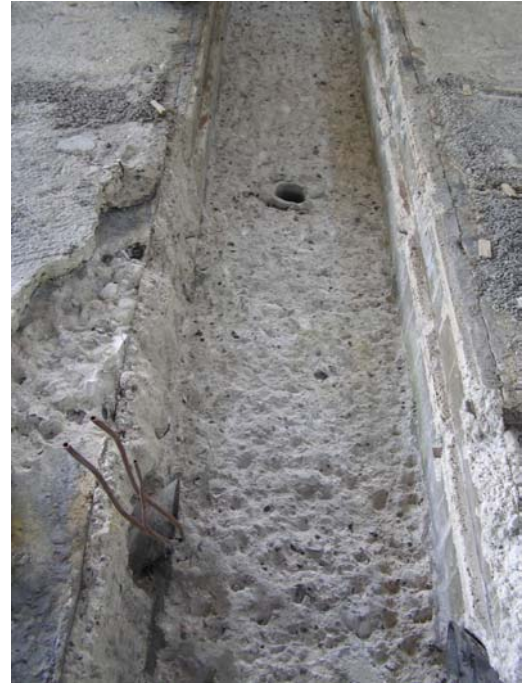
*Figure 61 The southern channel after decontamination*

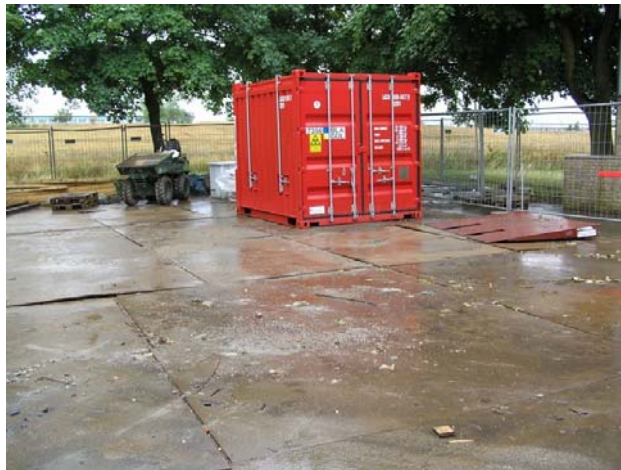
*Figure 62 ISO container for storage of DR 1 waste in the buffer storage hall*

The items in category 1 comprised the equipment from the reactor system itself (core vessel, recombiner, reflector graphite and miscellaneous piping), the inner parts of the biological shield and the concrete removed from below the reflector tank. The most active ones, i.e. core vessel, recombiner and some pipes, were transferred to shielded steel drums, which were placed in the above mentioned cell and later in a cave in the "Centralvejslageret". The less active items, such as the concrete slabs and rubble, were placed in an ISO container like the one shown in Figure 62. All items were wrapped in plastic foil or otherwise before being brought out to the containers outside of the building (the containers were too big to bring inside). The graphite stringers from the reflector were placed in pallet containers, which are temporarily stored in the "Centralvejslageret", not because they are very active but because the intermediate storage hall was not ready to receive waste at the time it was necessary to remove it from DR 1.

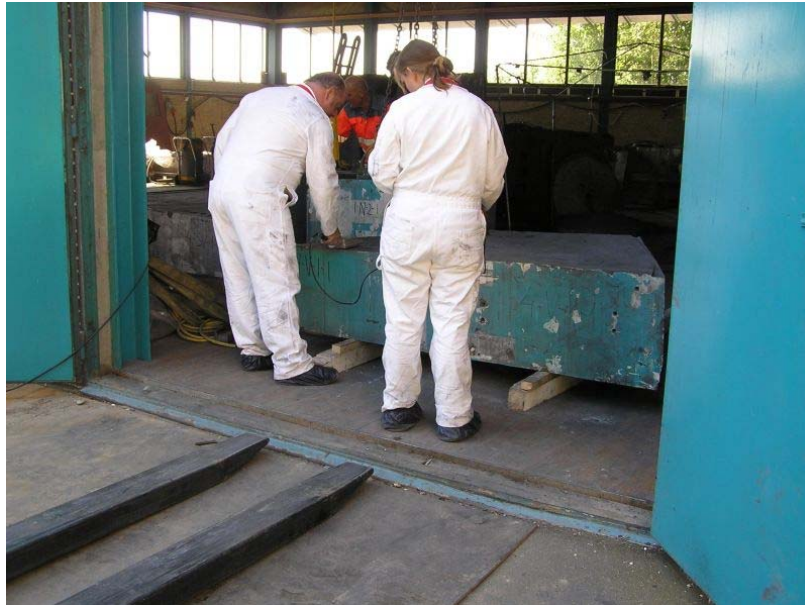
*Figure 63 Concrete block being checked at the exit from the reactor hall*

When the cleared blocks were to be taken out from the reactor hall they were cleaned for cutting sludge and subsequently checked on all surfaces for loose contamination and for  $\gamma$ -radiation. Smear tests were taken from all surfaces (but not covering all the surface area), and a 100% survey was made on all surfaces with a ZnS detector for control for hot spots or unexpected high radiation levels. Figure 63 shows a measurement taking place. The results were registered in a form like the one shown in Appendix 6 and had to be accepted by either the health physicist or the head of the Health Physics Laboratory before the concrete block could be cleared and placed outside the building, as shown in Figure 64.

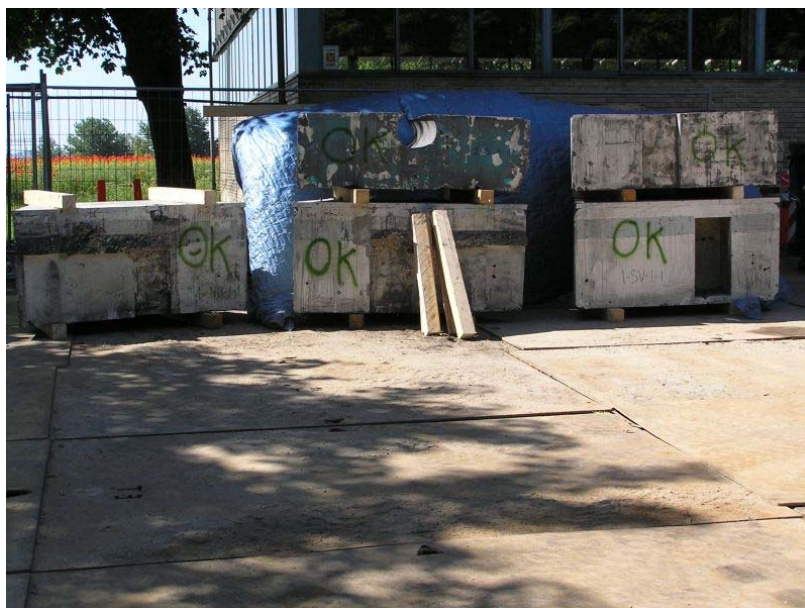
*Figure 64 Cleared blocks stored outside the reactor building*

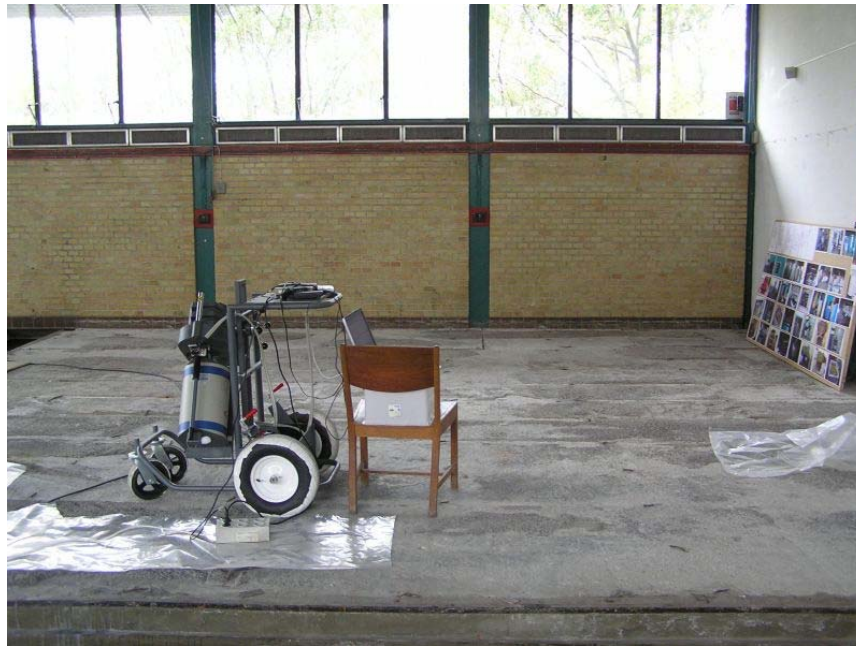
Figure 65 A Ge-detector set up for measurement on the upper part of the southern wall

In the reactor hall the brick walls and the window sills were measured with contamination monitors. The concrete wall to the west was measured with a contamination monitor up to a height of 2 metres above the floor. The rest of the walls were measured with Ge-detectors. Each upper wall was measured in two steps, each covering at least half of the wall. The detectors were directed at a point three to four metres below the ceiling. It was conservatively assumed that all the activity seen by the detector was located in one square meter that was positioned farthest away from the detector. Most likely the contamination will be evenly distributed on the wall. Figure 65 shows the setup for measurement of part of a wall.

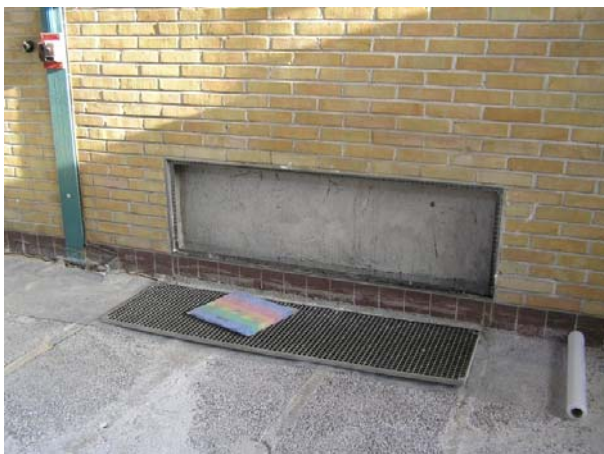
The ducts for the heating system are not accessible. It was assumed that if any contamination were to be found in the ducts, it could be detected behind the outlet grills at the southern end of the hall. The walls behind the grills were measured with contamination monitor. No contamination was detected. Some dust behind the ventilation grills was scraped off and analysed by gamma-spectrometry in the laboratory. The sample showed small amounts of  $^{137}\text{Cs}$  and  $^{60}\text{Co}$ . Assuming conservatively that there was a dust covering of half a kilogram per square meter, the surface contamination of  $^{137}\text{Cs}$  would be less than  $1500\text{ Bq/m}^2$  and that for  $^{60}\text{Co}$  less than  $200\text{ Bq/m}^2$ . It was, therefore, concluded, that the contamination of the ducts would be far below the clearance levels. The channels for the ventilation ducts, running along the northern and southern walls, had been covered with concrete and the wooden floor. One access hole to the channels was situated in the northern channel for the pipes leading to the fission gas station and another access hole in the southern channel for electric cables. It was assumed that if any contamination was to be found in these channels it would be close to these access holes. Therefore, the areas in the channels around the access holes were measured with a contamination monitor. No contamination was found. Figure 66 shows the wall behind one of the outlet grills and Figure 67 shows one of the channels with the ventilation ducts.

Figure 66 One of the three outlets for the air heating system

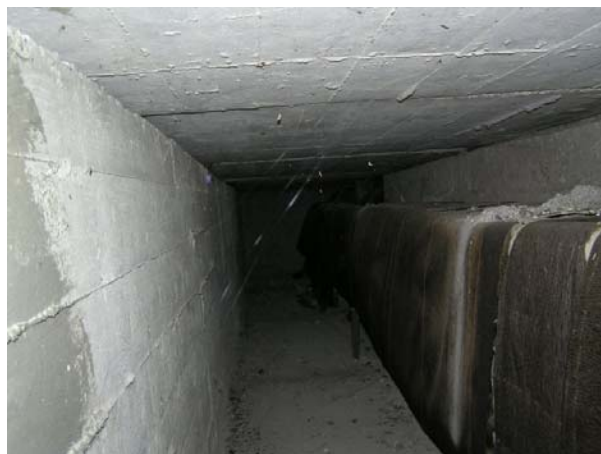
Figure 67 A view into the northern channel with an air heating channel to the right

Wipe tests from the inside of the ventilation channel revealed that the channel was slightly contaminated with  $^{137}\text{Cs}$ . Although much of this contamination probably originated from weapons test fall-out or from the Chernobyl accident, this could not be verified by analyses of the wipe samples. Therefore, it was conservatively assumed that all of the  $^{137}\text{Cs}$  in the ventilation outlet should be included in the calculations of the clearance index. A measurement was made with a collimated Ge-detector pointing directly at the ventilation channel, showing a surface concentration of  $^{137}\text{Cs}$  less than  $3000 \pm 800\text{ Bq/m}^2$  at any one square meter, i.e. well below the clearance level of  $10^4\text{ Bq/m}^2$ .

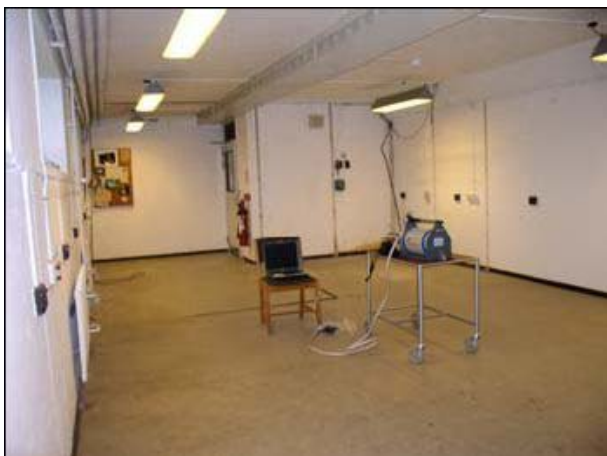
*Figure 68 Ge-detector in the counting laboratory*

toilet in the basement were measured by means of both contamination monitors and spectrometers, because some contamination had been found (and removed) in the counting room, and slightly elevated radiation levels had been found in the locker room and toilet. The reason for the latter turned out to be that some tiles had a significantly higher content of  $^{40}\text{K}$  than other tiles in the room.

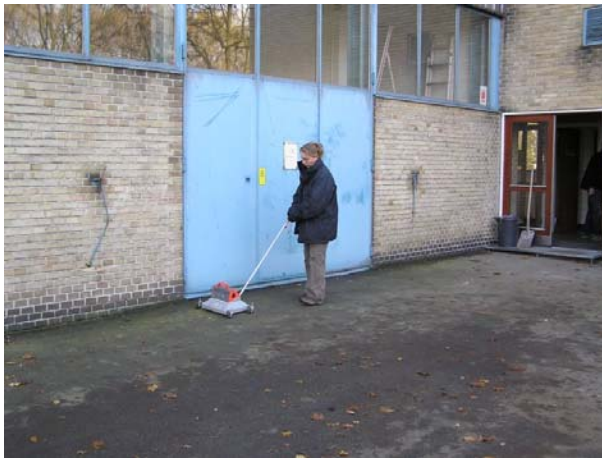
The asphalt to the north in front of the reactor building was measured to 100% coverage for contamination with contamination monitors, cf. Figure 70. No contamination was found. One measurement was made with a Ge-detector on the asphalt area. A background spectrum was measured at a Risø area with a similar type and age of asphalt. No radionuclides resulting from the operation and decommissioning of DR 1 was found in the measurement on the asphalt in front of the DR 1 building. East and south of the building measurements were made with a Ge-detector. Background measurements were made at areas at the Risø-site with similar characteristics. Figure 71 shows the measurement east of the DR 1 building. No contamination resulting from the reactor operation and decommissioning was found. The outdoor staircase to the basement on the west side of the building was measured with a contamination monitor. No contamination above background levels was found.

*Figure 70 Measurement with contamination monitor north of the building*

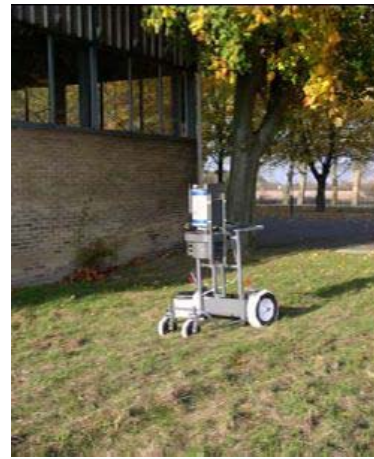
*Figure 71 Measurement with Ge-detector east of the building*

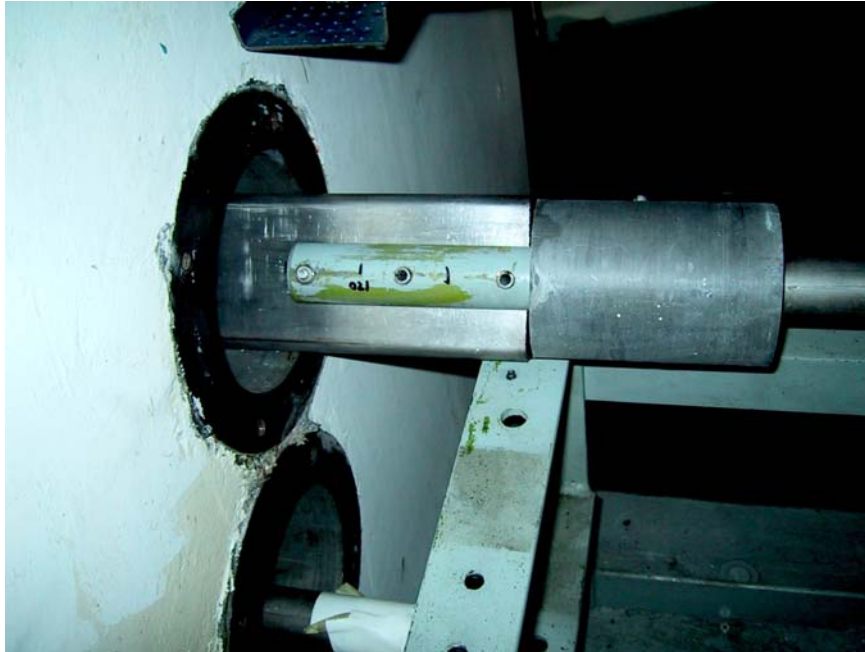
*Figur 2 Samling af kontrolelement og forbindelsesstang*

- 1. sikkerhedsstav (**øverst til højre i huset – nr. 1 på fig. 1**) trækkes ud til blyklods og fæste er frit (se fig. 2)
- Rørsplitter (2 stk.) og bolt fjernes og forbindelsesstang frigøres (se fig. 2).
- Kontrolblad mærkes med "1" (som i fig. 1) i den mindst aktive ende, udtages og placeres i en plasticpose (~15×150 cm), som nedsættes i beholder.
