Decommissioning of DR 2

Final report

DD-38 Rev.1 (ENG)
February 2009

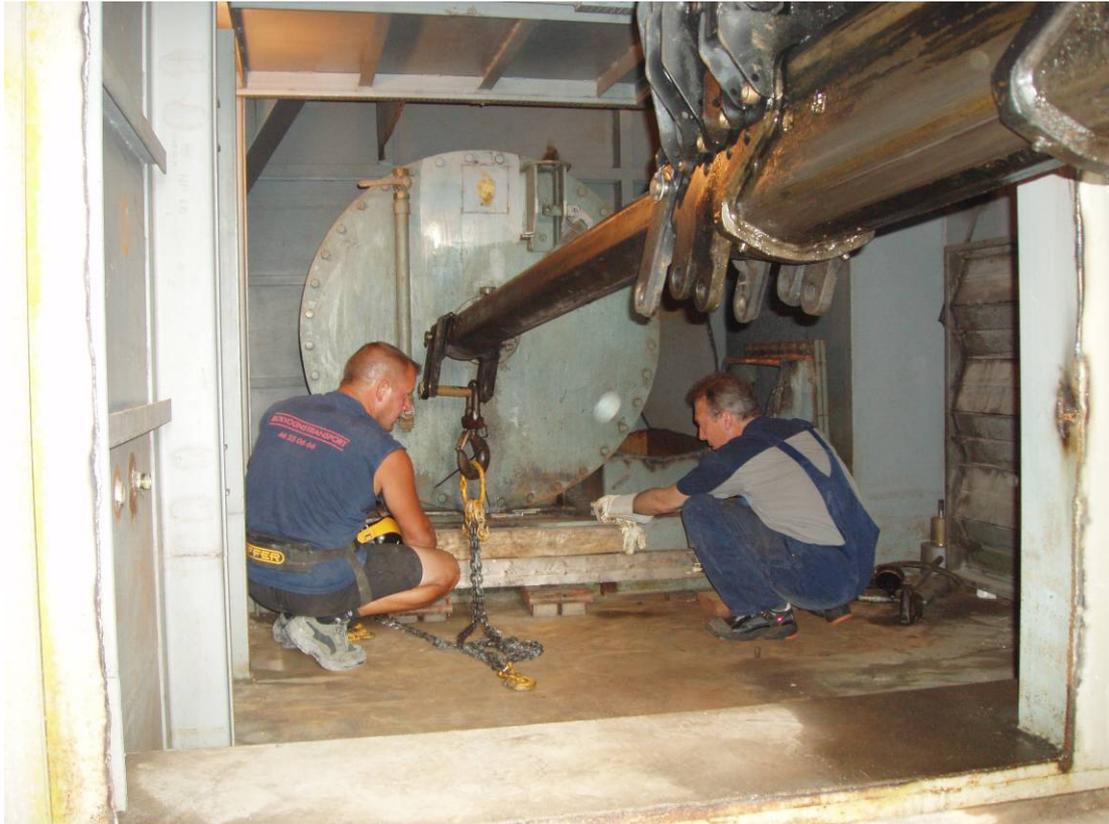
Figure 8. Preparing to remove a Gako valve.

First a hole was cut in the pressure chamber using a cutting torch. After the valves had been dismantled, they were lifted and pulled out with the use of ingenuity, muscles and a mobile crane.

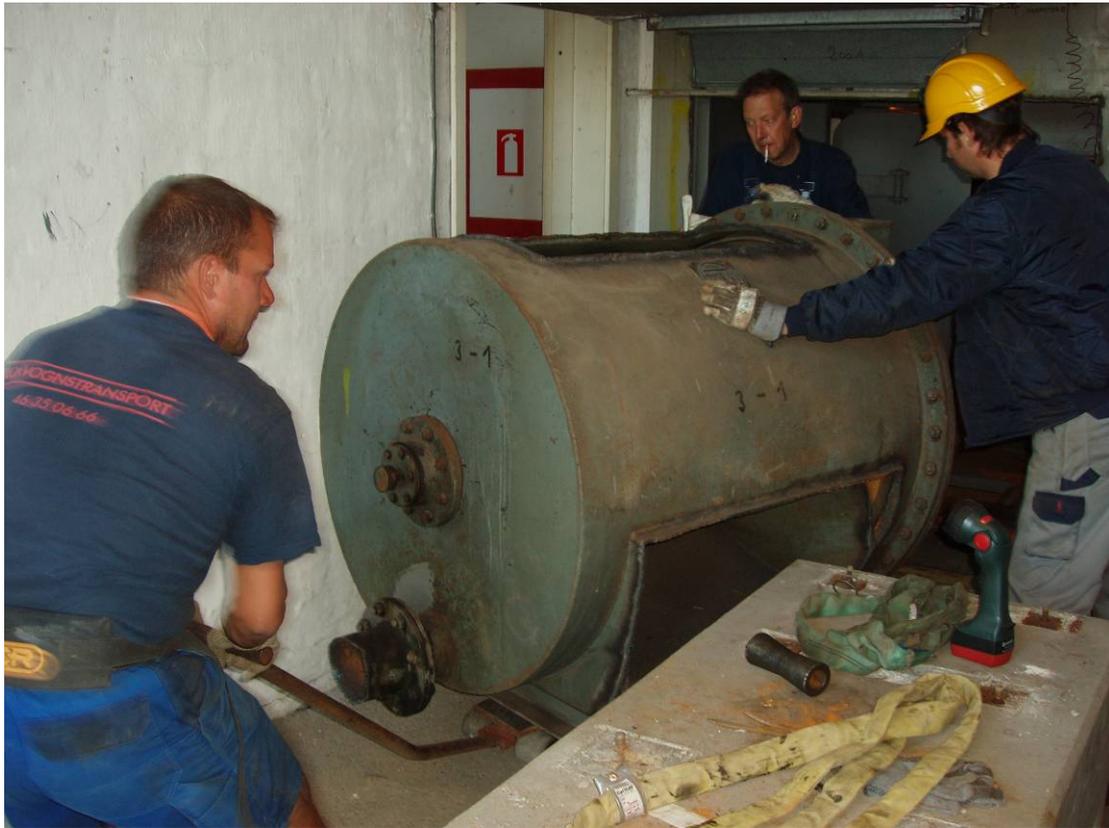
Figure 9. Removing a Gako valve.

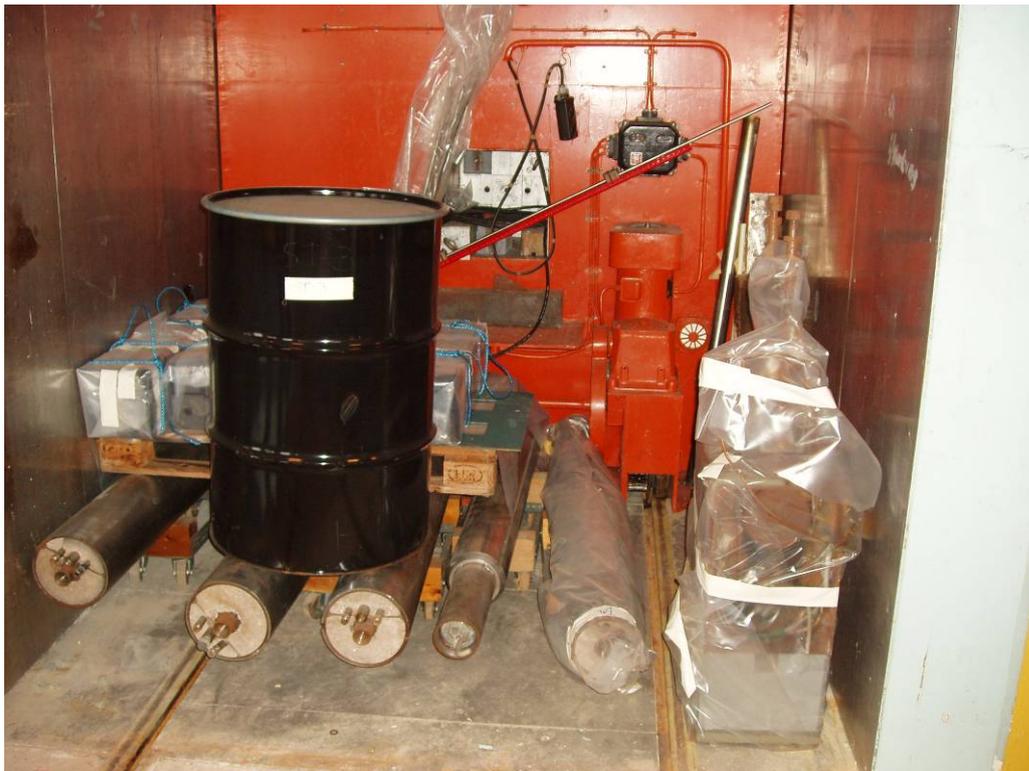
Since the igloo contents had been stored for many years, it was expected that the items might be pretty dusty and the work was planned accordingly – i.e. the individual components were moved one at a time and vacuumed just outside the igloo. Subsequently, a first control measurement was made. It was then decided what was going to happen with the individual component. No contaminated dust was found.

Figure 12. Items stored in the igloo.

When the igloo was opened, various contaminated auxiliary tools and other items from the operating period, such as graphite from the thermal column, dummy plugs from horizontal beam tubes, etc., were found. These are described in "The DR 2 Project" [10].

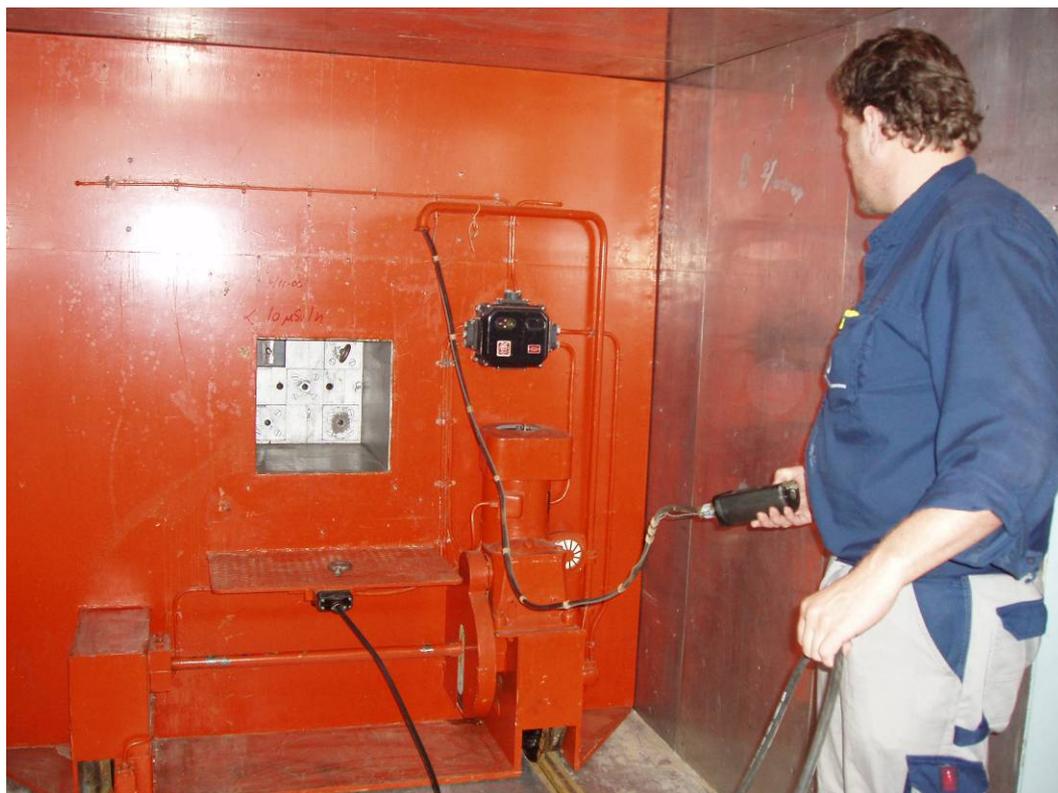
The sliding door was made from heavy steel and magnetite concrete. The total weight of the door was about 16 tonnes. Control measurements showed that the central part around the plug had been activated while DR 2 was in operation. It was thus decided that the sliding door would subsequently be partitioned and the activated parts removed. It is expected that only a minor part (< 1 tonne) will have to be deposited as active waste and that the remaining part can be removed as cleared waste. This work has been planned for subsequent execution, cf. section 11.2.

Figure 13. The sliding door is run out. At the centre is the plug for removing graphite for the thermal column. The rail system can be glimpsed at the bottom.

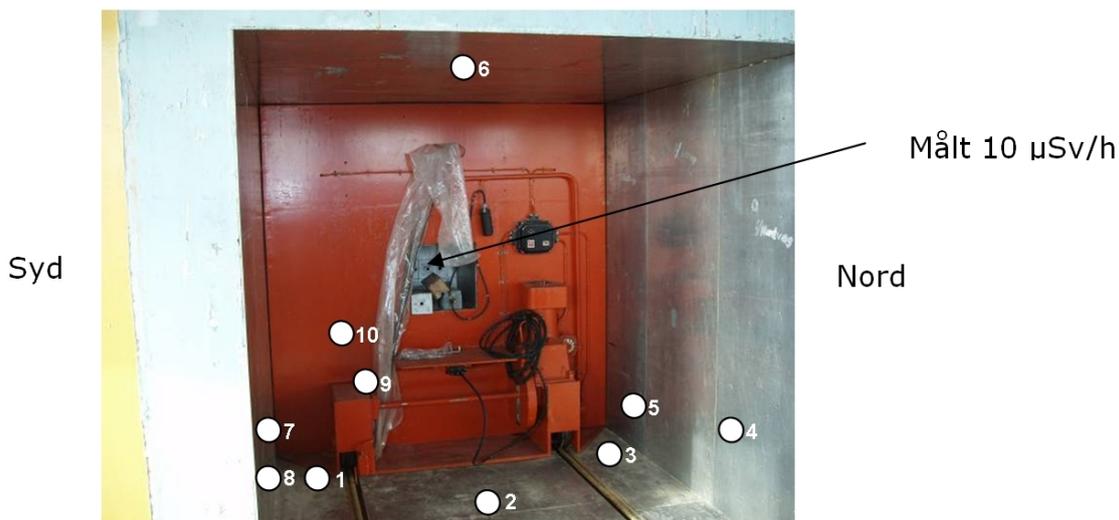
Figure 14. Measurements in the igloo before the sliding door was removed

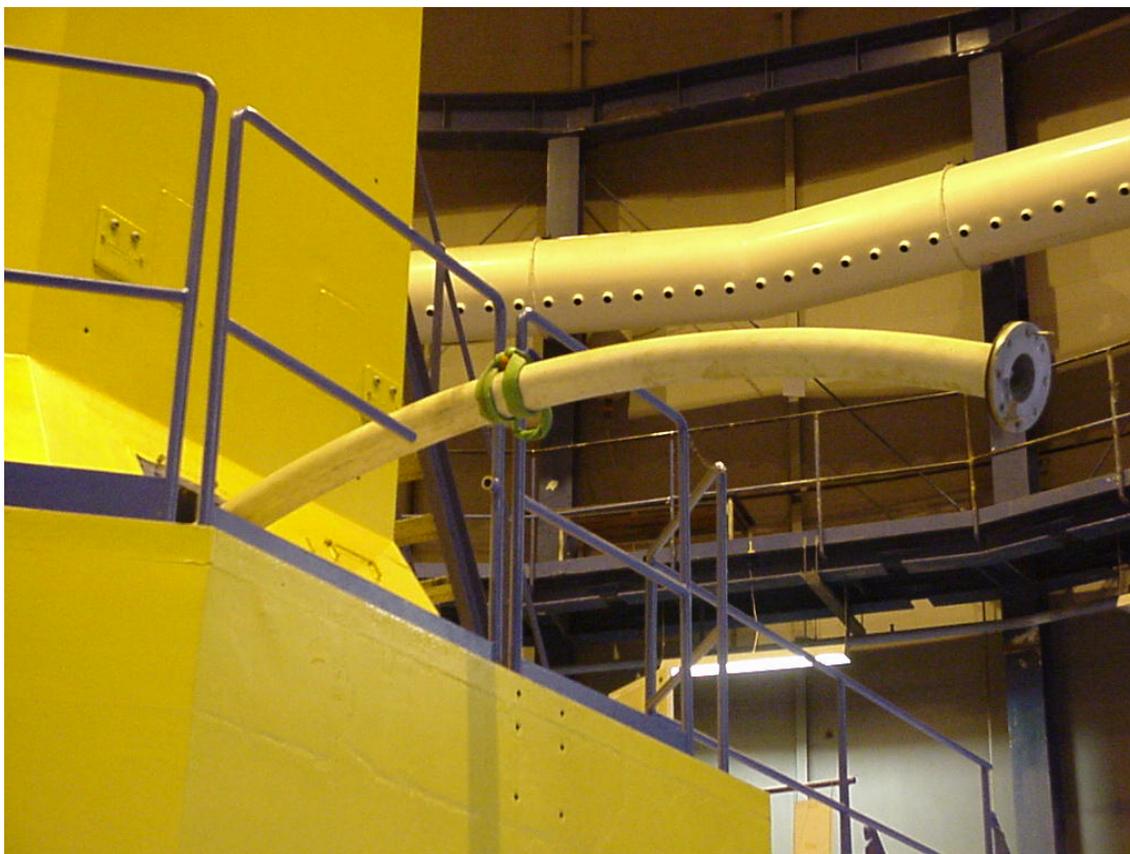
In characterisation, 600 $\mu\text{Sv/h}$ was measured at the bottom surface of S-2, declining to half of that level at 40 cm distance from the bottom. The total activity of the six S-tubes was assessed to be approx. 0.1 GBq.

Figure 17. Removal of S-5 tube.

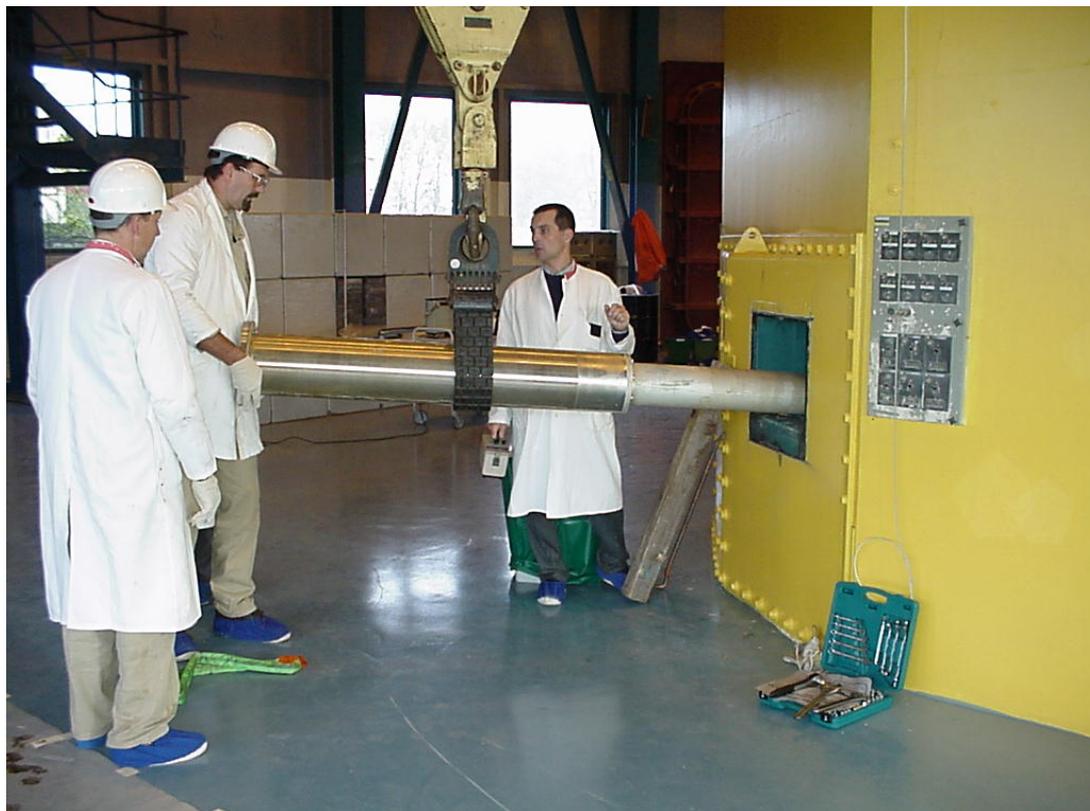
For the characterisation, the total activity of the eight B-tubes with linings was estimated to be approx. 1 GBq, although with quite some uncertainty.

Figure 19. Removing the B-3 tube (photo from the characterisation project).

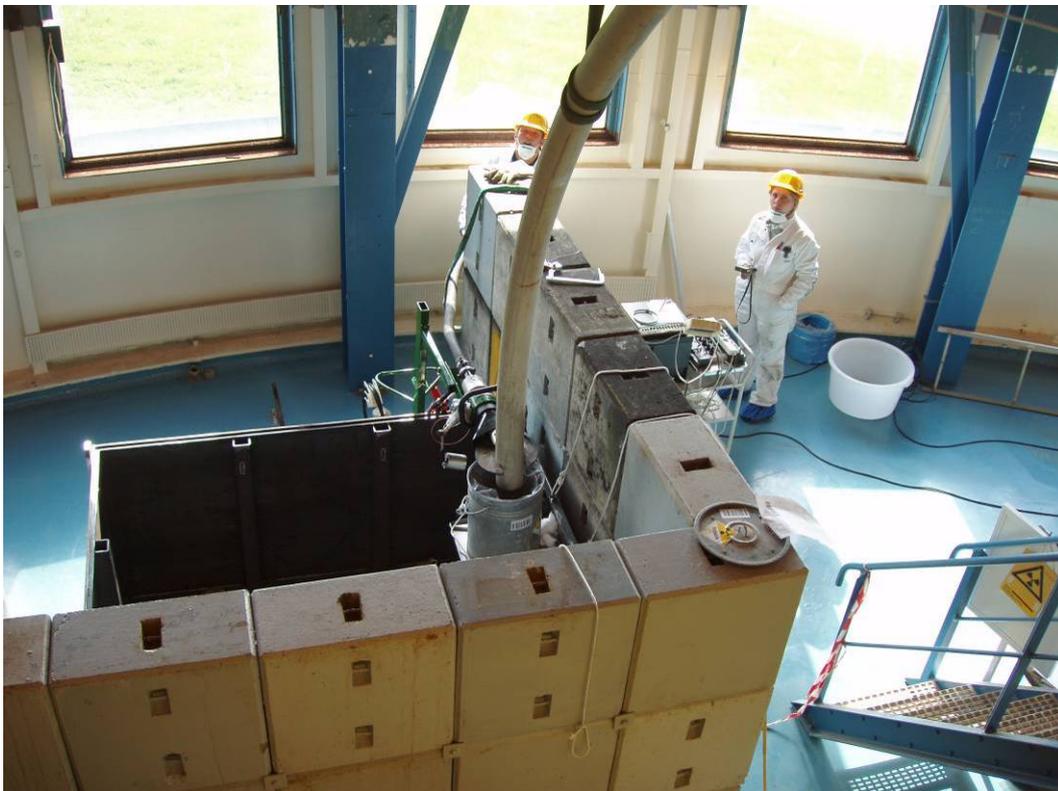
Figure 22. Placement of remote-controlled shear above container. A camera has been mounted on the shears themselves. The monitor is outside the shielding.

The partitioning of S- and R-tubes was made behind the shielding by cutting off the activated parts and dumping them straight into a steel container by means of remote-controlled hydraulic shears (figure 22).

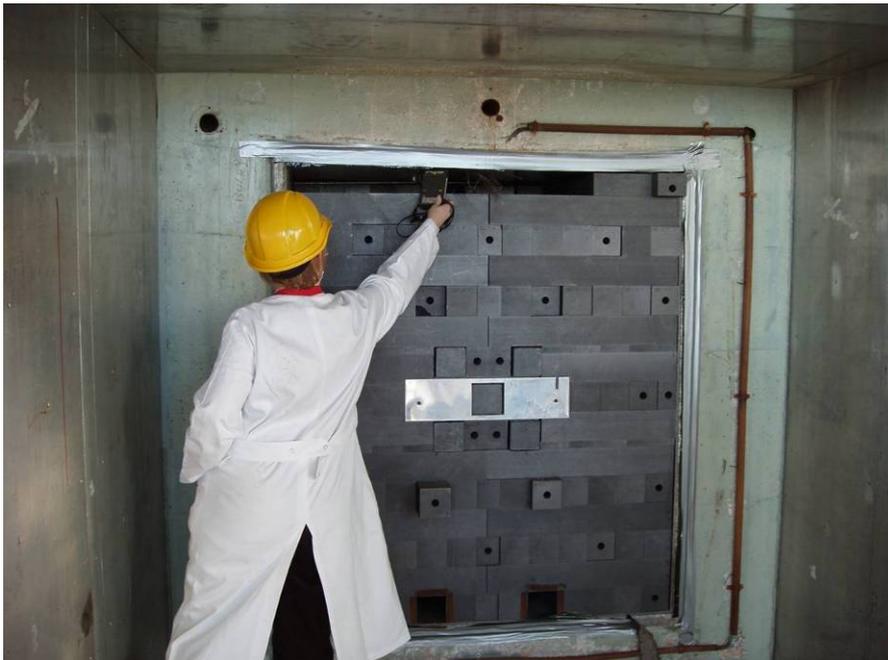
Access for measuring the radiation level could be ensured from the graphite on the outside, but there were concerns that the inner part of the stringers would give off significant radiation levels. For this reason, the decision was made to minimise staff handling of the graphite material.

Figure 24. Thermal column with graphite; radiation level is measured.

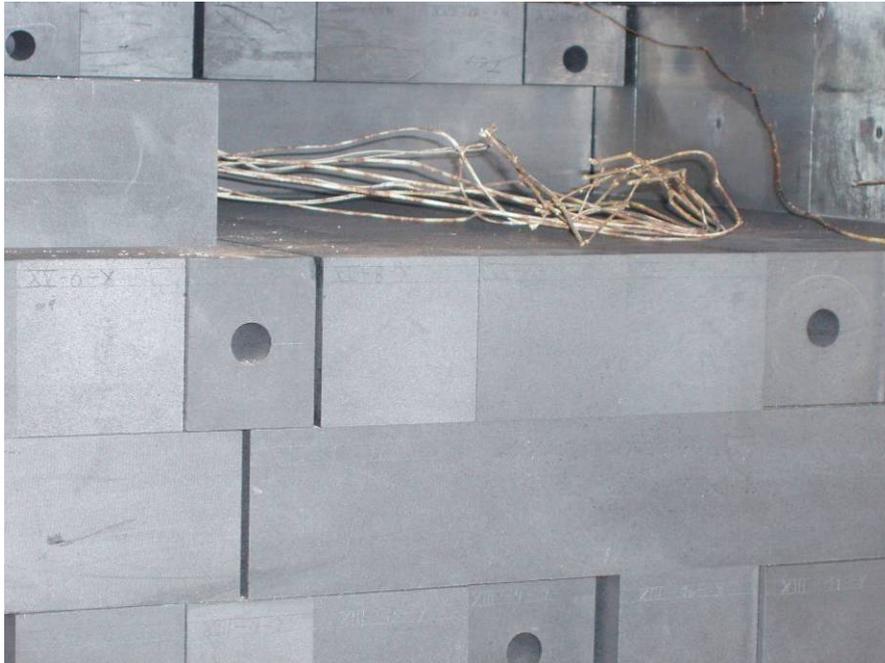
Figure 25. Graphite stringers, cross bond visible, and cables for thermocouples in lead nose exposed.

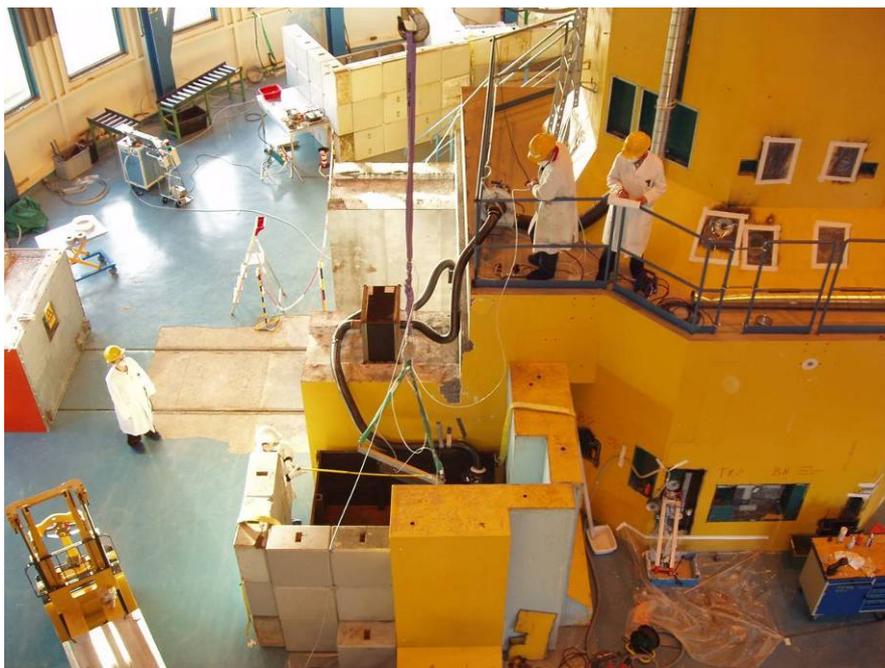
Figure 26. Set-up for shielding and remote-controlled handling of graphite removal and container packing.

To begin with, a work area was established in the DR 2 hall with suitable shielding of containers, shielding around the thermal column and with the possibility of remote-controlling equipment and handling items. Control and monitoring were possible e.g. directly from the reactor block balcony.

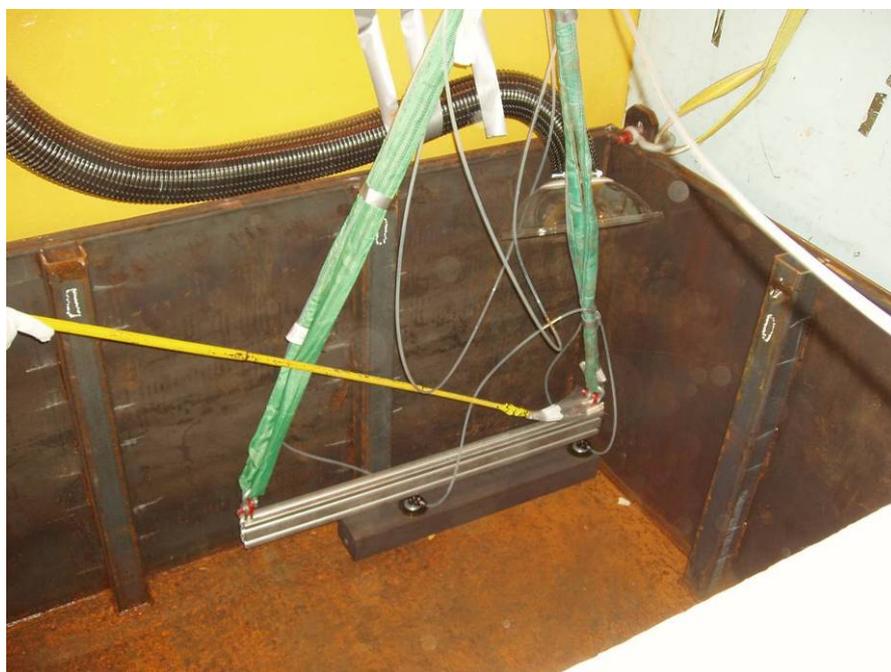
Figure 27. A graphite stringer being removed by using a vacuum lifting device and placed in a DD steel container.

For lifting the graphite stringers, the pressure tools were fitted on an aluminium bar. An extender was also fitted with a pressure device to pull the stringers out of the thermal column. The removal of the stringers by means of the suction disc devices turned out to be effective, so the work was carried out safely and in accordance with the work schedule.

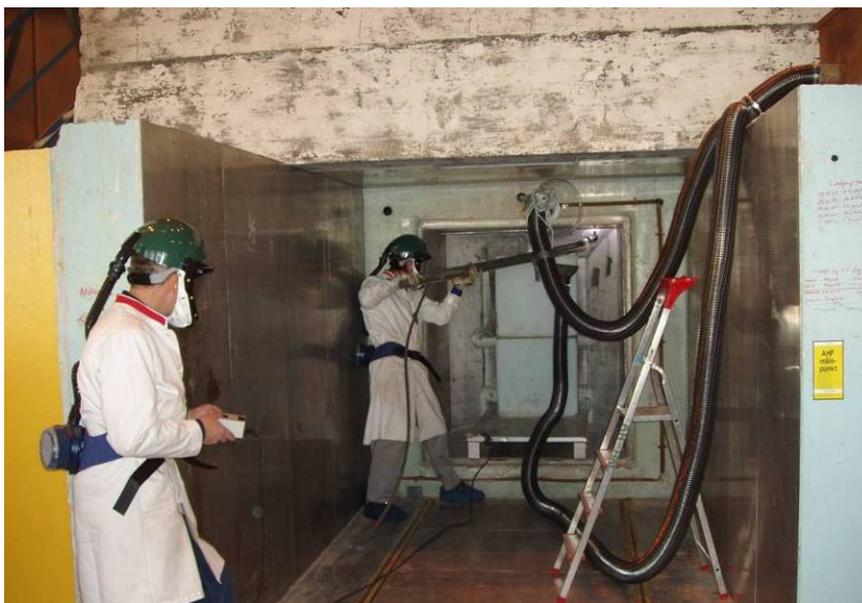
Figure 30. Plasma cutting of lead nose. Shielding with concrete blocks at the centre; local air extraction used.

Cutting of the lead nose from the thermal column was made by fitting the plasma cutter to a 2-metre extender. Cutting was performed by two DD technicians – one of whom performed the cutting using the extender, while the other handled the voltage switch from about 4 metres from the column. This was found to be the safest solution for reducing personnel doses, but was also used because the plasma cutter requires high voltage and works by means of electric contact (an electric arc of up to 20,000 volts) between the cutter head and the item to be cut.

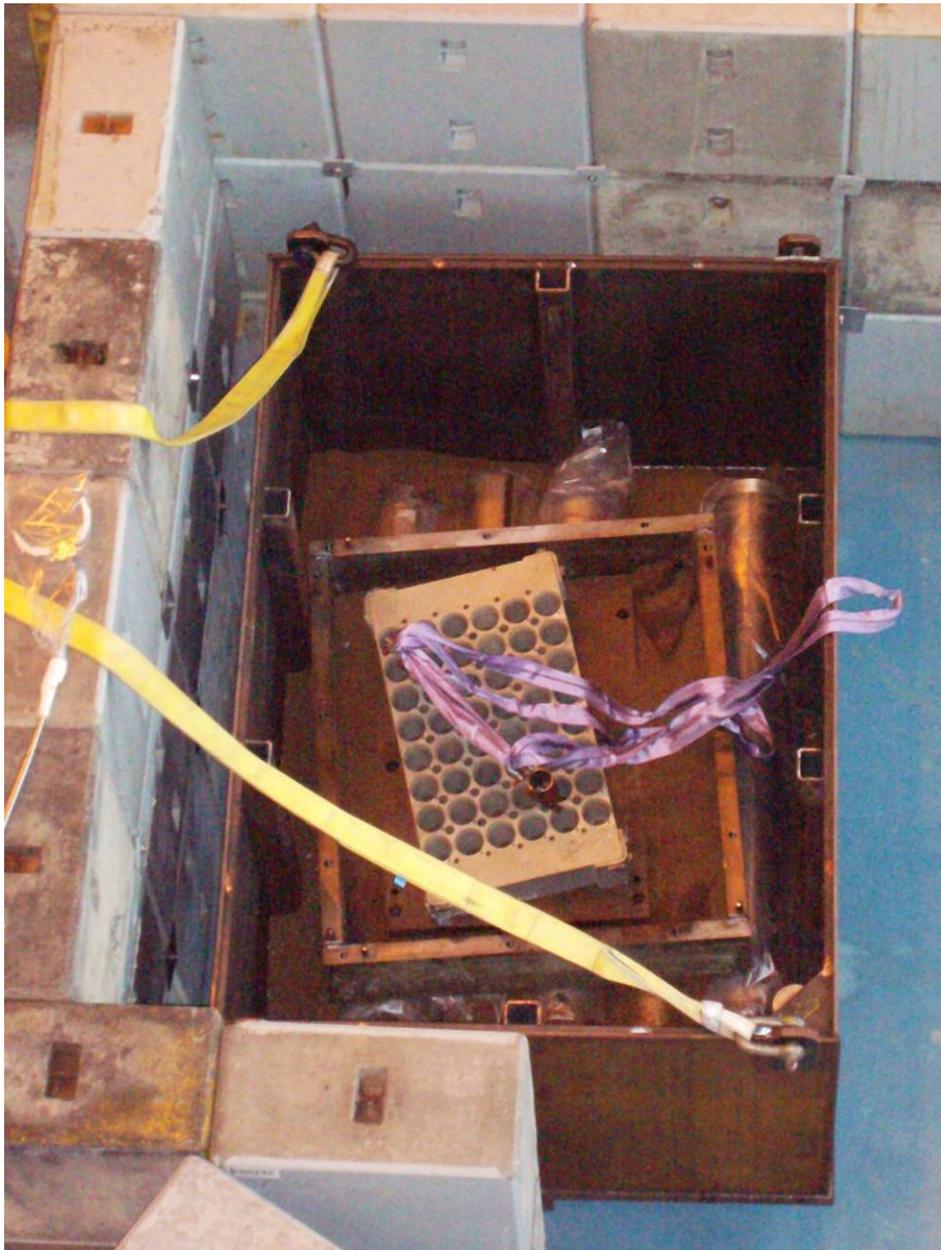
Figure 34. The grid plate in the container before it was closed. The shielding box and plugs are barely visible at the bottom.

A steel box, approx. 20 cm high, was made also from 40 mm steel. The grid plate was placed in the box and the steel plate placed on top of this improvised shielding box. Another layer of steel balls was placed on top. The container was now in compliance with the surface dose rate requirements for being stored in the intermediate storage facility, cf. chapter 8.

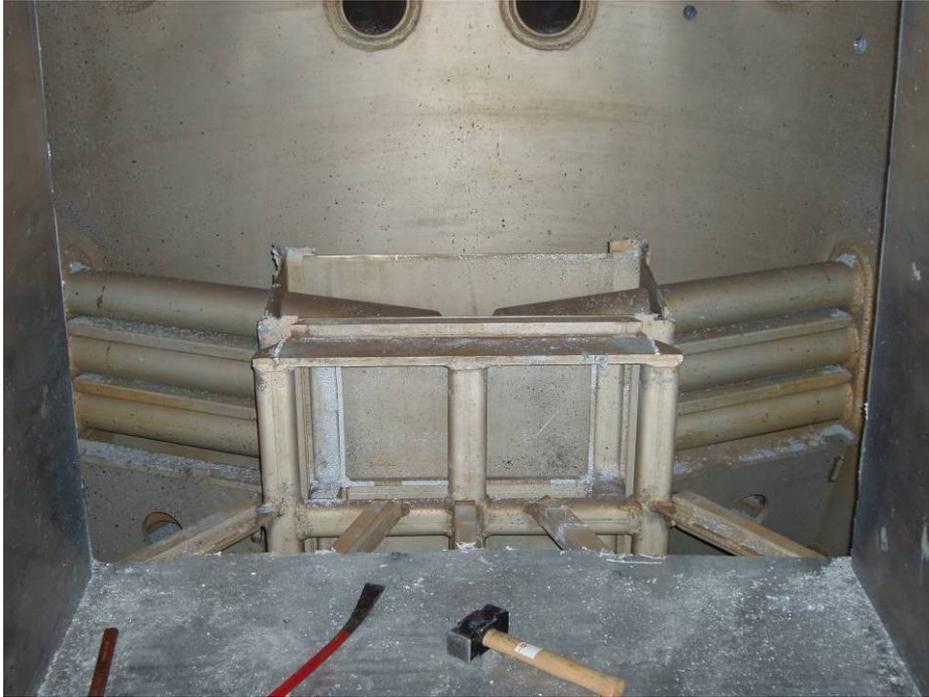
After removing the grid plate, the radiation level in the reactor tank was found to be down to 20 $\mu\text{Sv/h}$,⁹ so it was possible to perform the remaining work manually on site.

Figure 35. The remaining inside structure after removal of the grid plate. Lead covers on instrument thimbles have been removed.

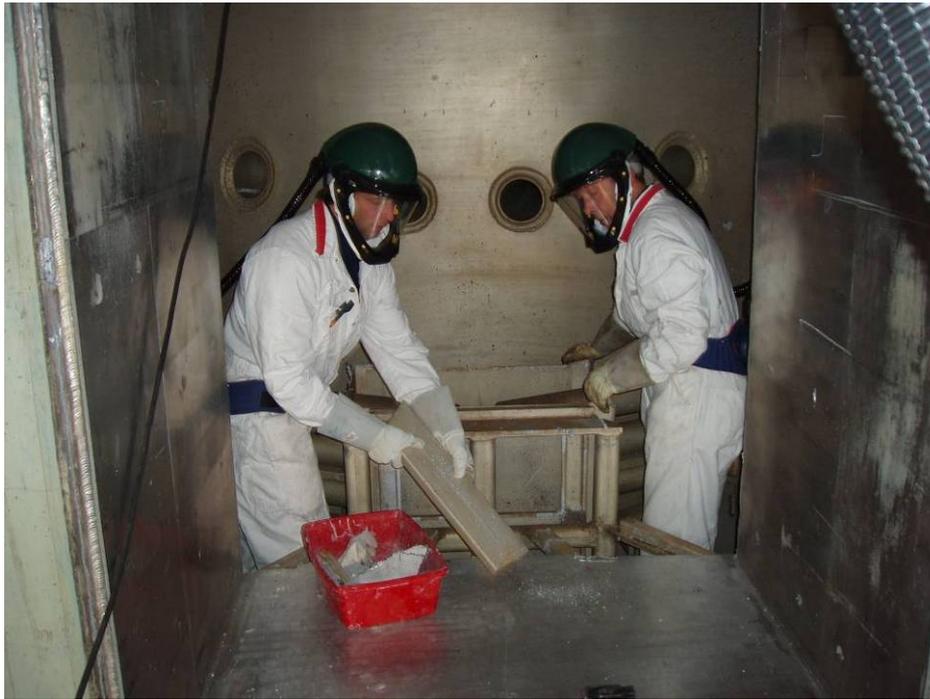
Figure 36. The last internal parts of the reactor tank being removed.

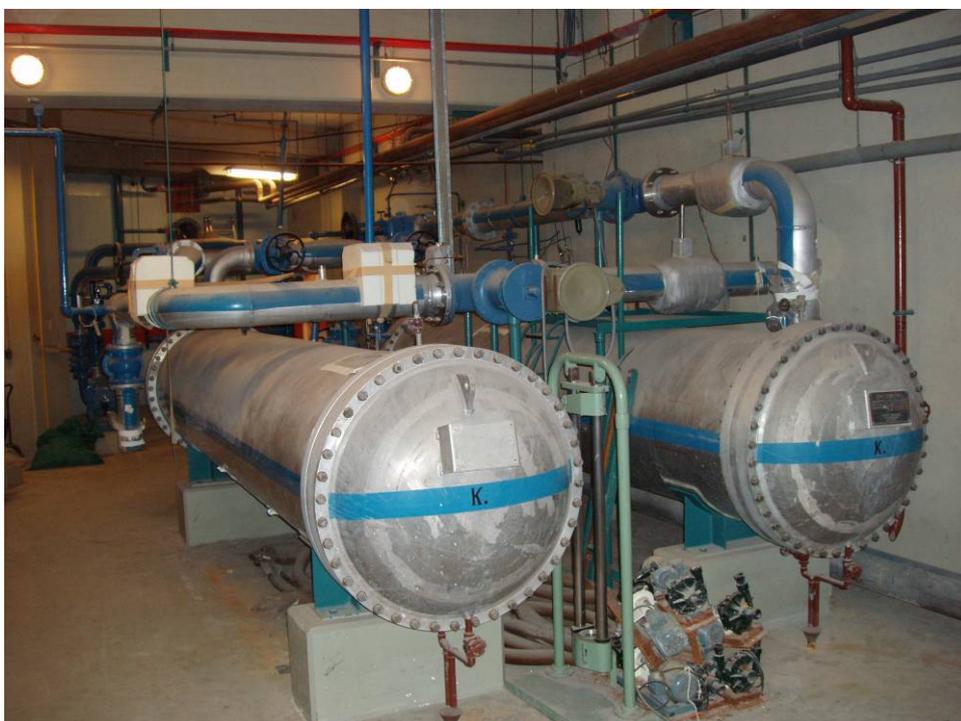
Figure 38. Heat exchangers in the equipment basement before removal.

At first, the heat exchanger end plates, which were bolted, were removed and sent to decontamination without much difficulty. The inside pipes, on the other hand, were not so easy to remove. 'Wear and tear' – surface erosion and deposits on the pipes meant that it was not possible to pull out the pipes completely through the tube plates. It was thus decided to partition the pipes before removal.

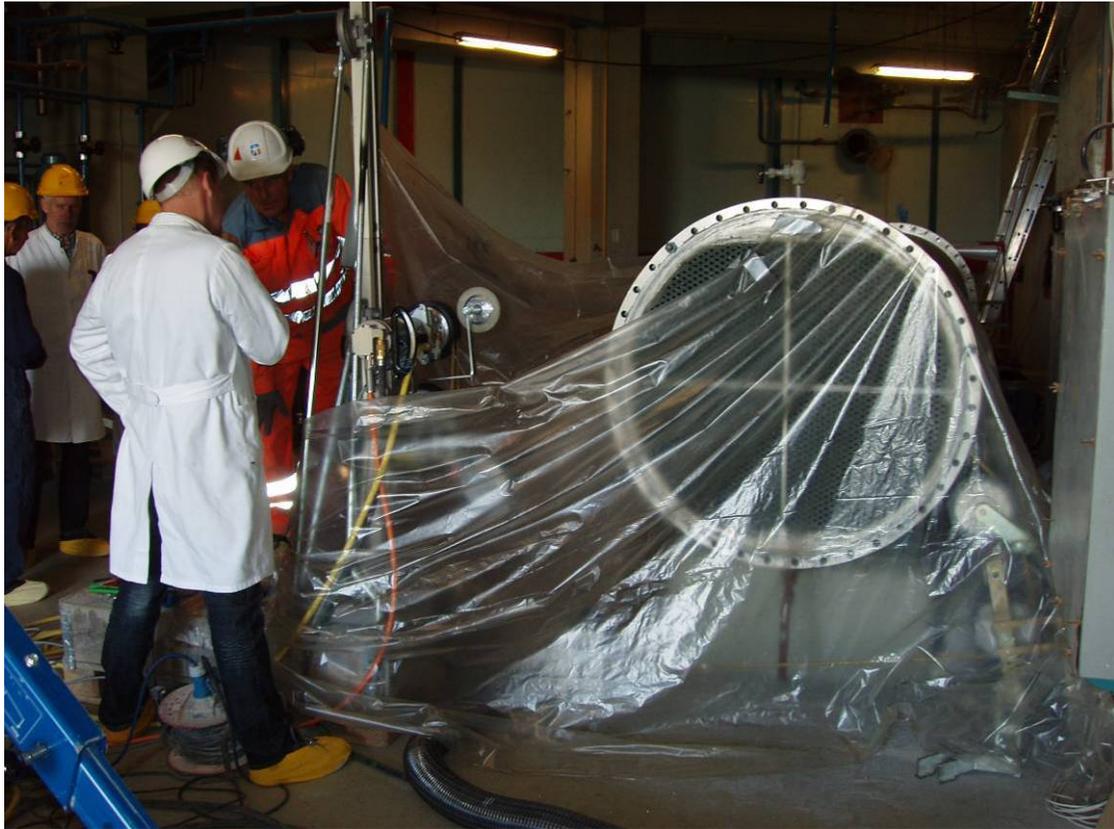
Figure 39. Set-up for dry wire-cutting of heat-exchanger pipes.

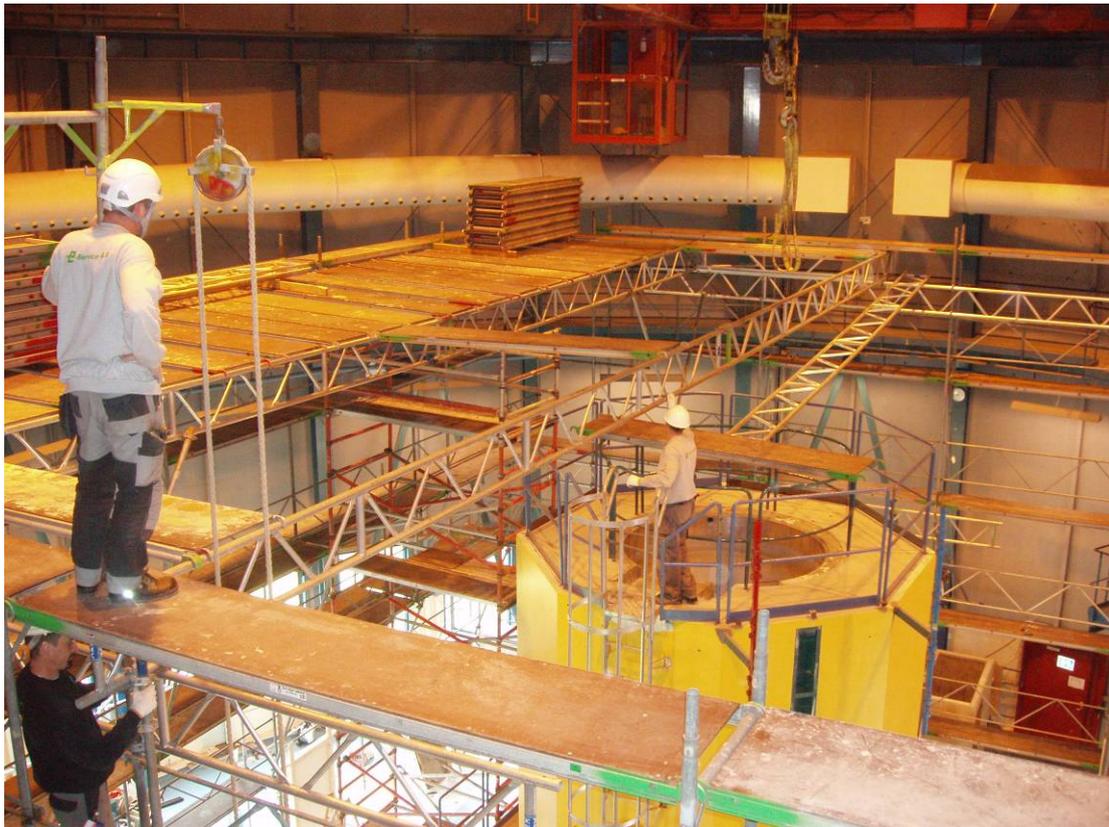
Figure 43. Scaffolding built up around the reactor.

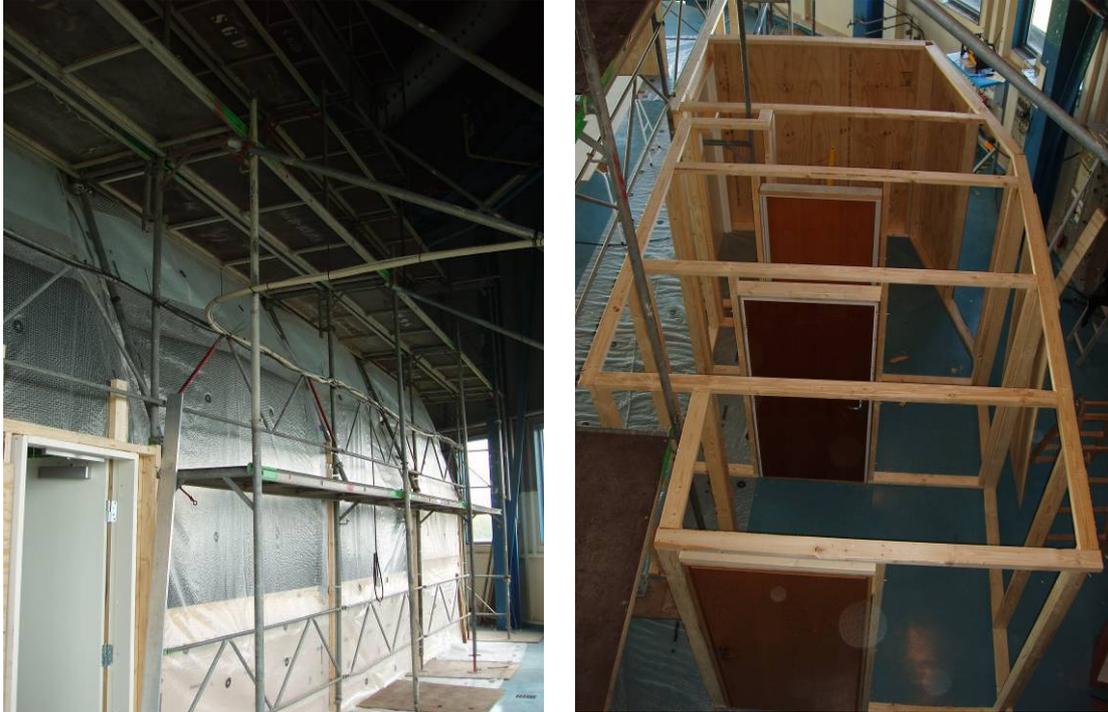
Figure 45. Scaffolding covered with tarpaulin on the inside; three-section person lock being built.

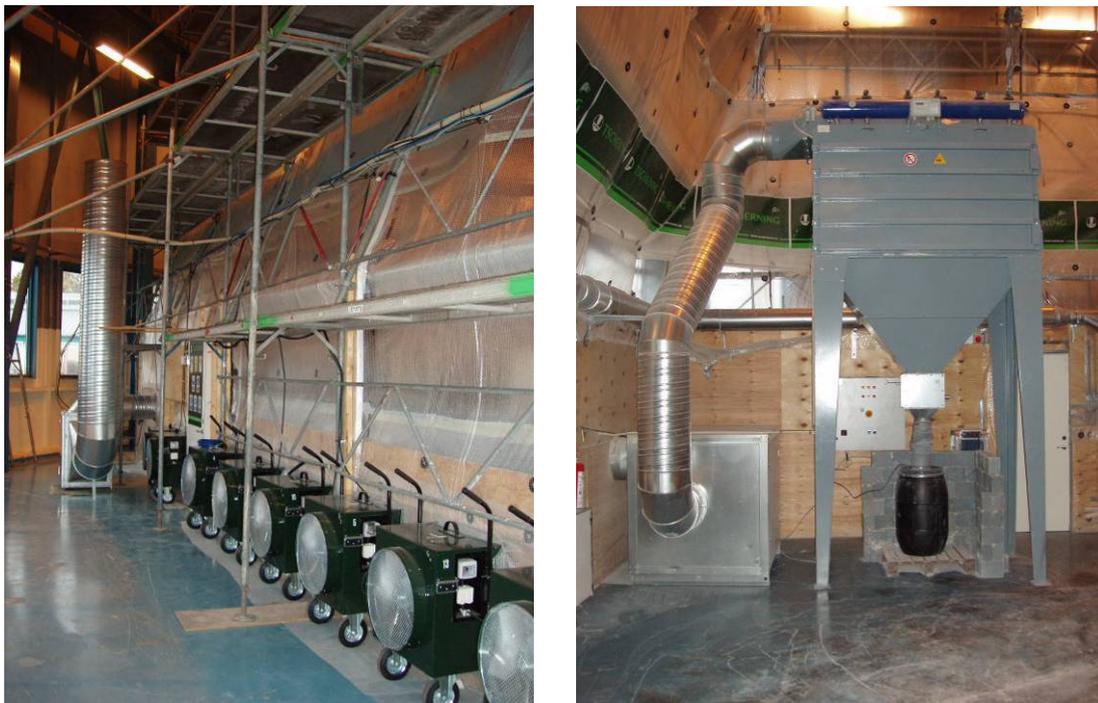
Figure 46. Left photo: extraction system on the discharge side; at the back discharge from a local extraction point. Right photo: system for local extraction with a drum for collecting dust; discharge via HEPA filter.

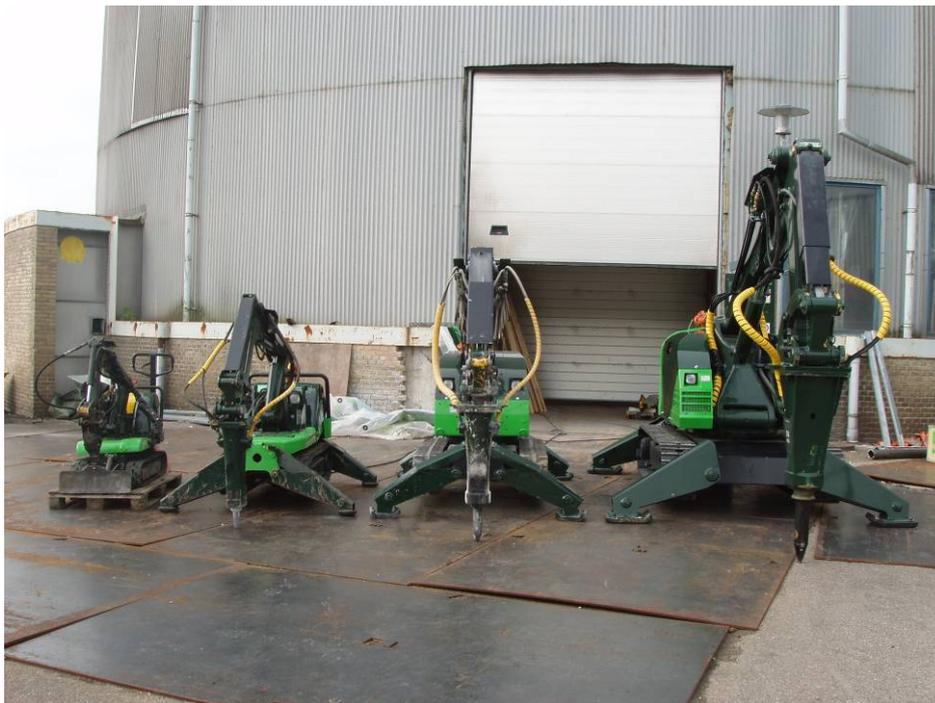
Figure 50. Remote-controlled demolition robots of the 'Brokk' type; these were used for the assignment.

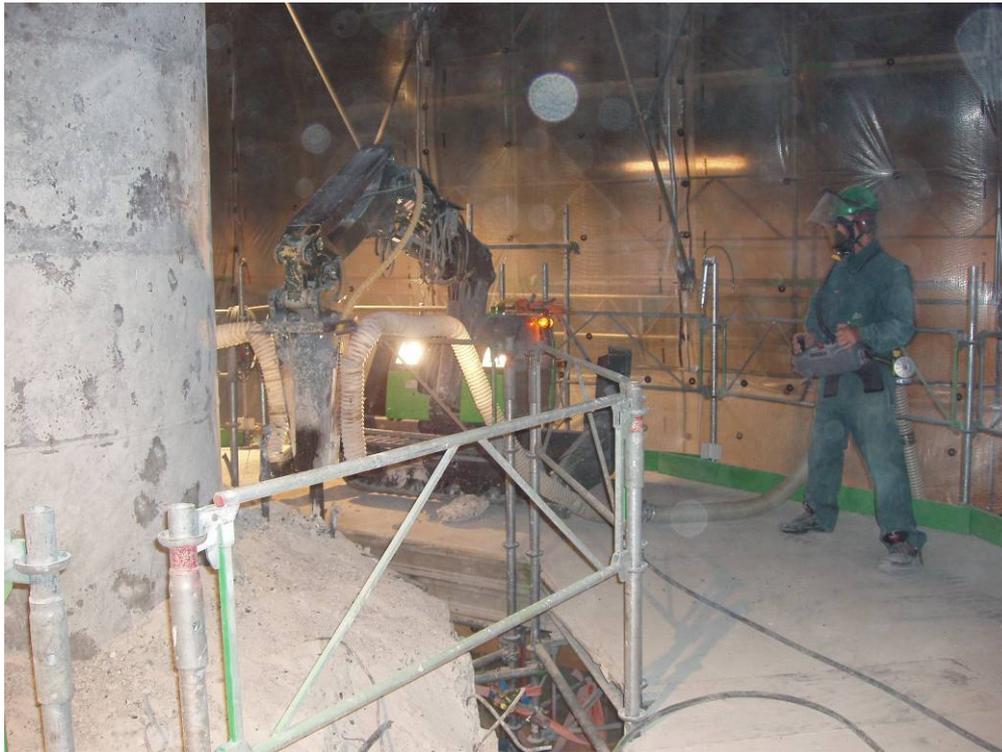
Figure 52. Demolition of chimney from platform. Remote-controlled demolition robot 'Brokk90' in action.

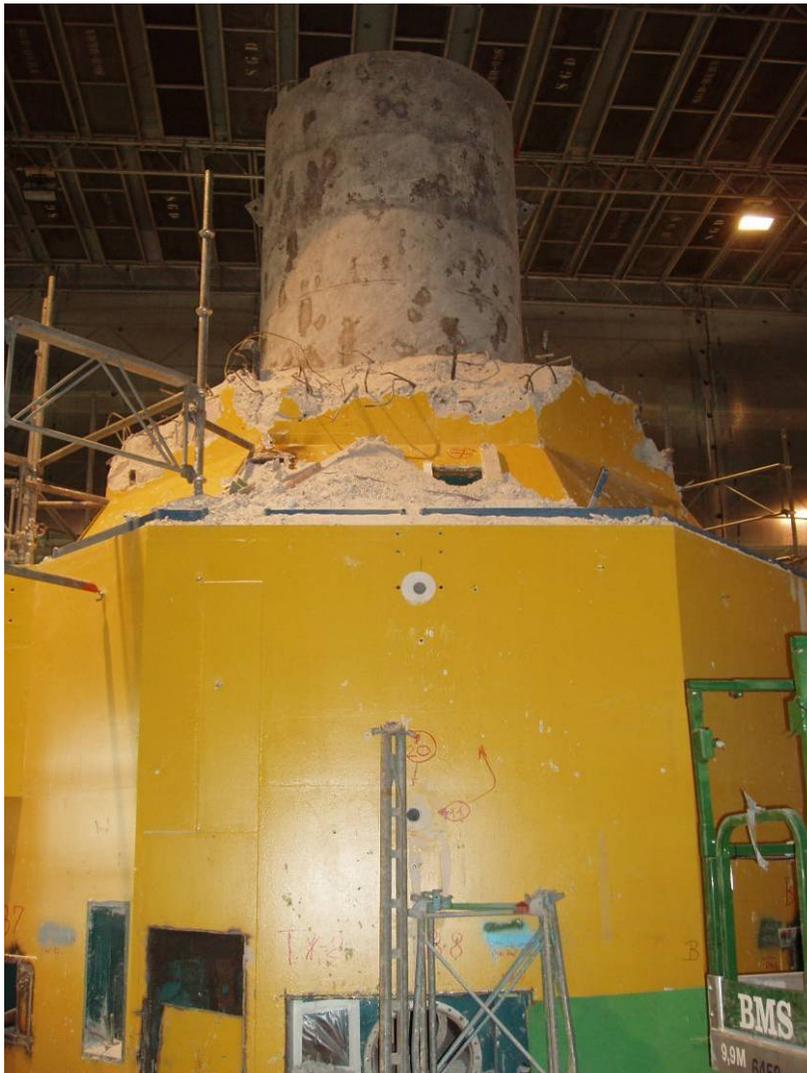
Figure 53. Chimney broken up; platform is removed; reactor tank awaits cutting up.

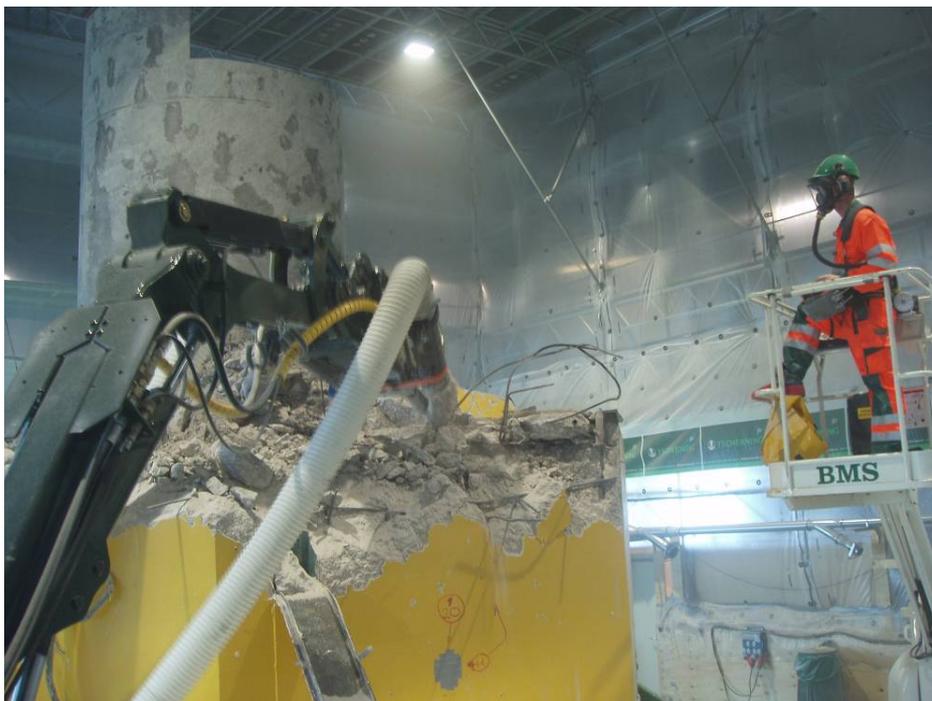
Figure 55. Demolition of upper part. Demolition robot 'Brokk330' remote-controlled from the lift.

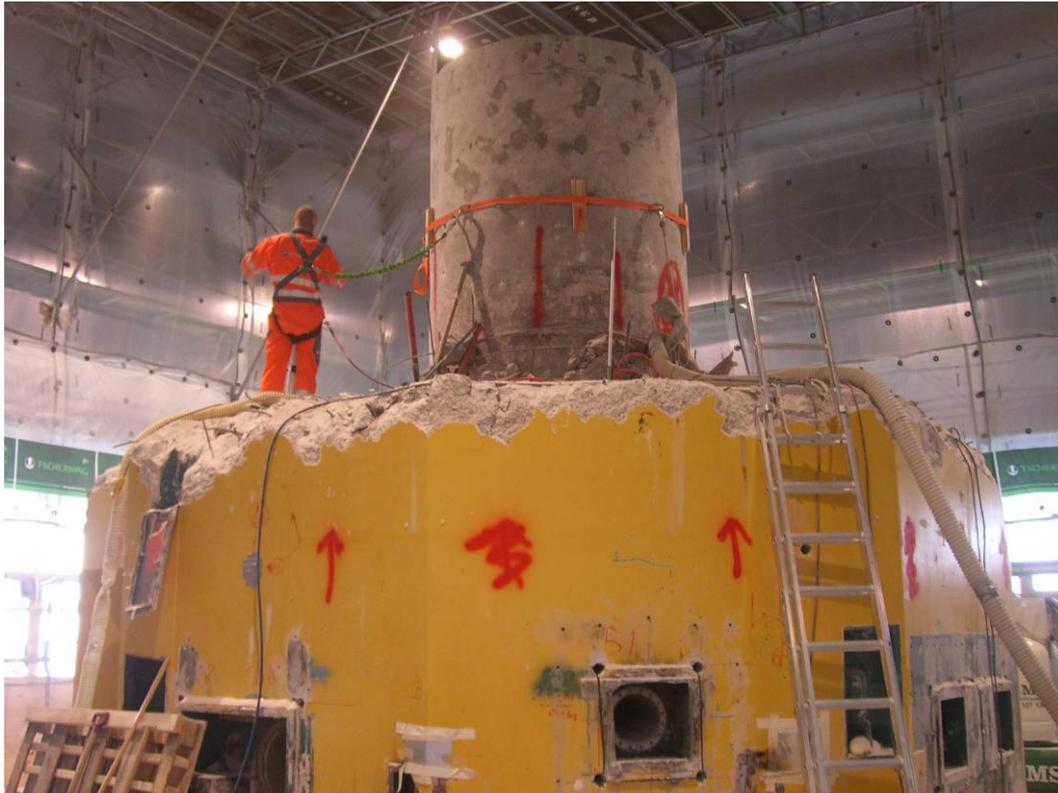
Figure 56. Upper part of the reactor block broken up and preparations for cutting down the reactor tank.

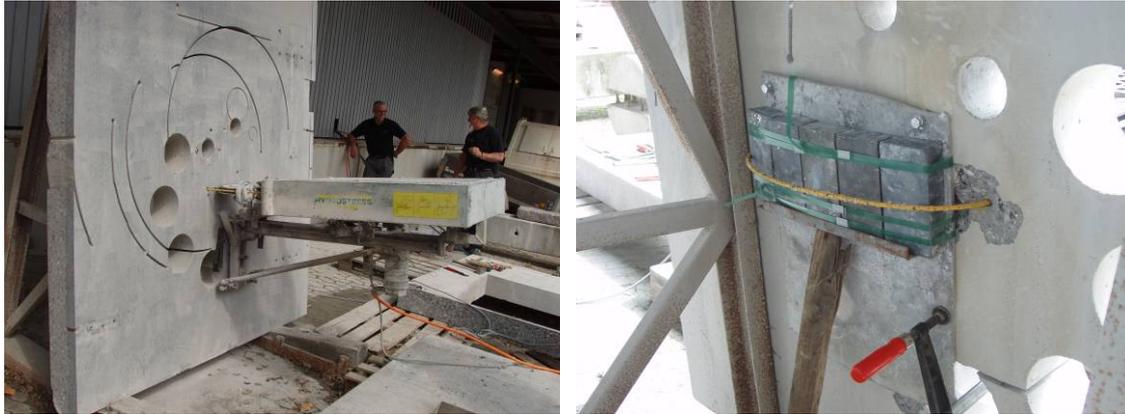
Figure 57. Test structure set-up for a test cutting using wire.
