Decommissioning of DR 2

Final report

DD-38 Rev.1 (ENG)
February 2009

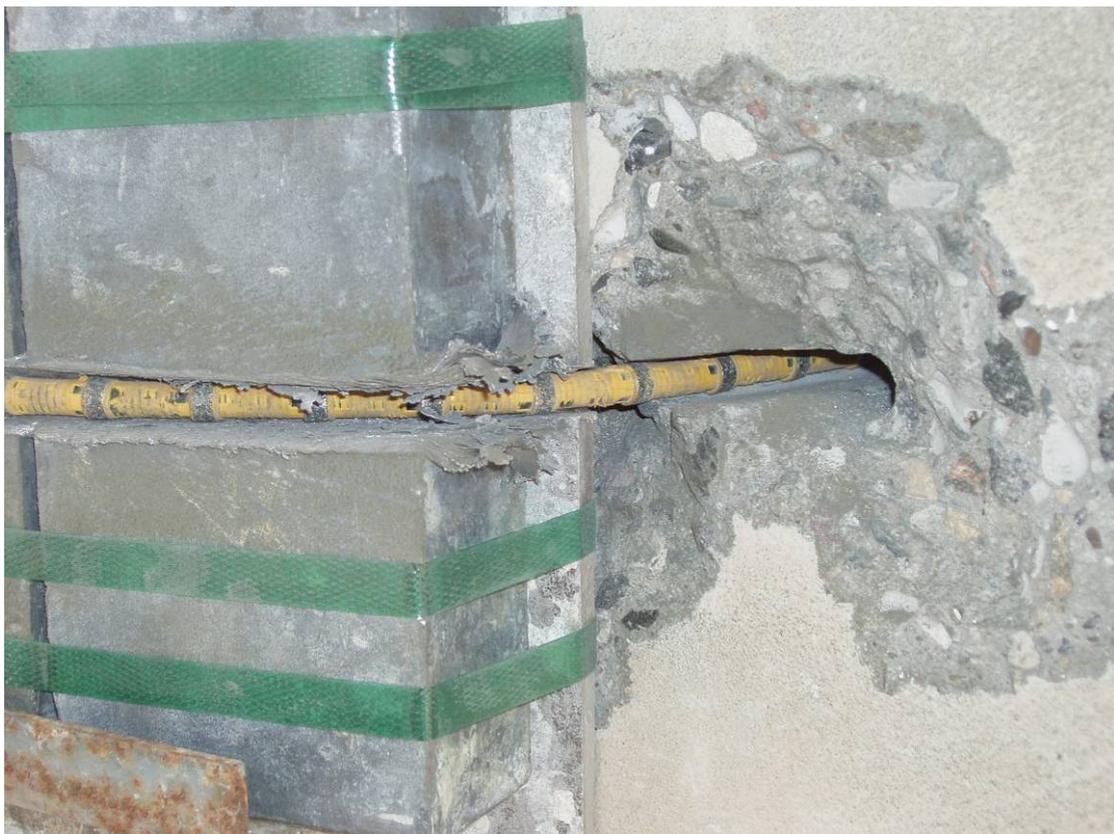
Figure 58. Example of cutting lead using a wire.

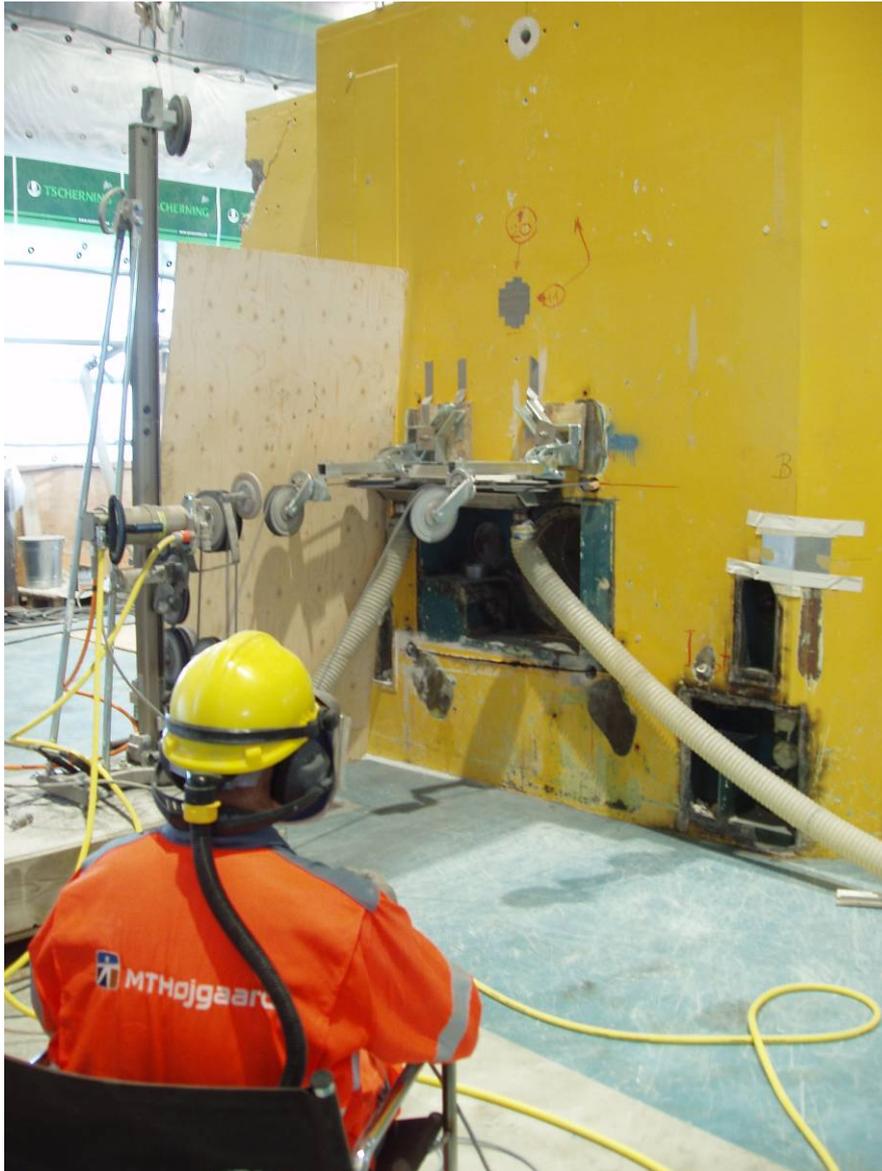
Figure 59. Cutting of horizontal tubes using wire.

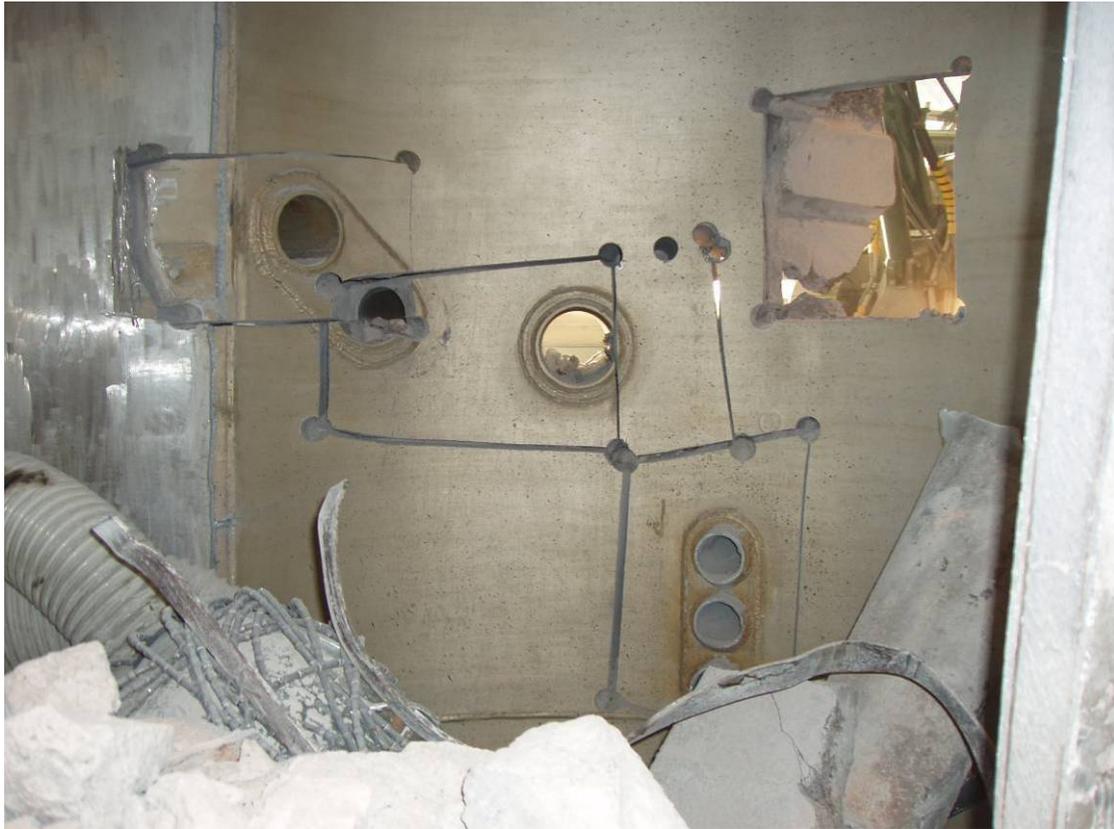
Figure 61. Reactor tank seen from the inside during the cutting of horizontal tube blocks.

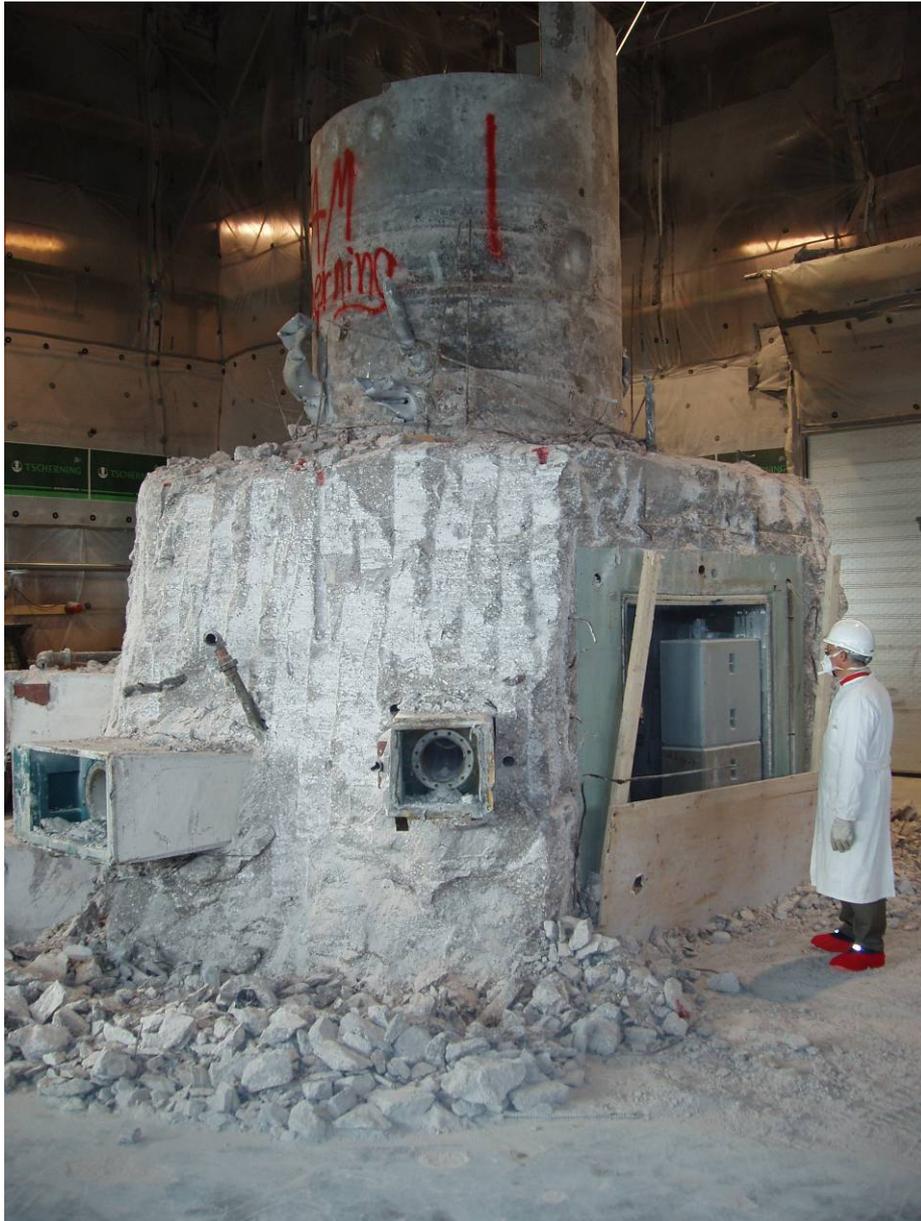
Figure 63. Process step 5 completed. Activated concrete part “exposed”.

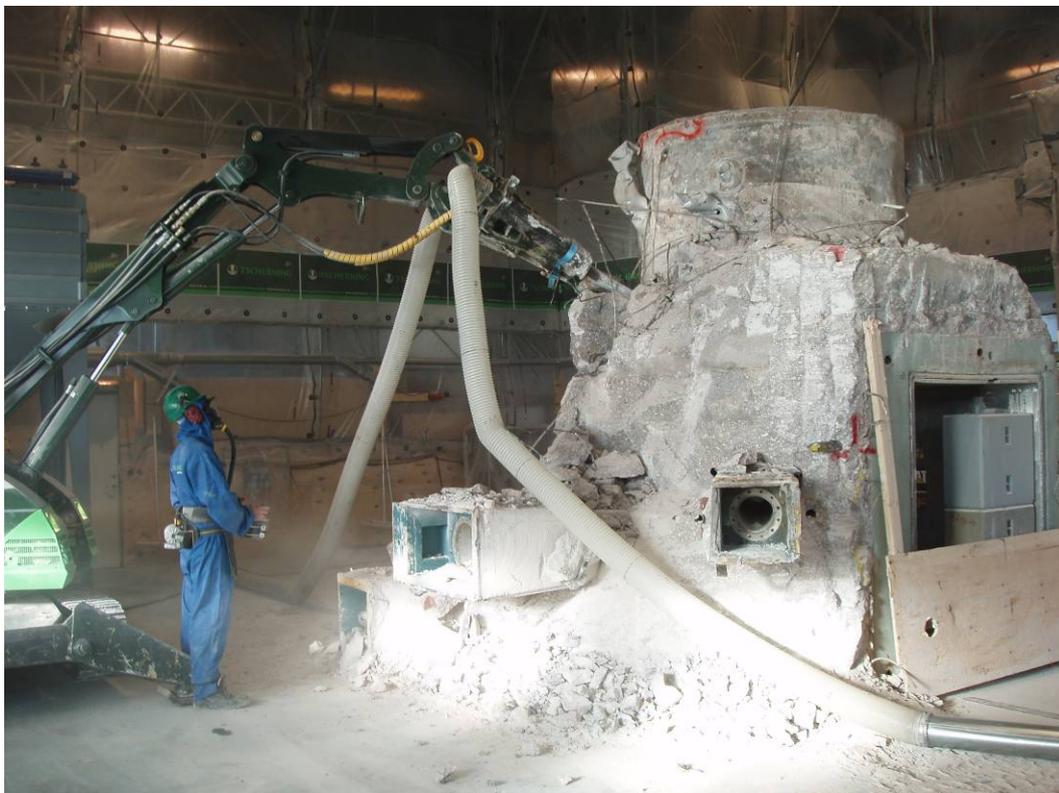
Figure 65. Demolition of activated part of reactor block. Local extraction system fitted on a hydraulic hammer.

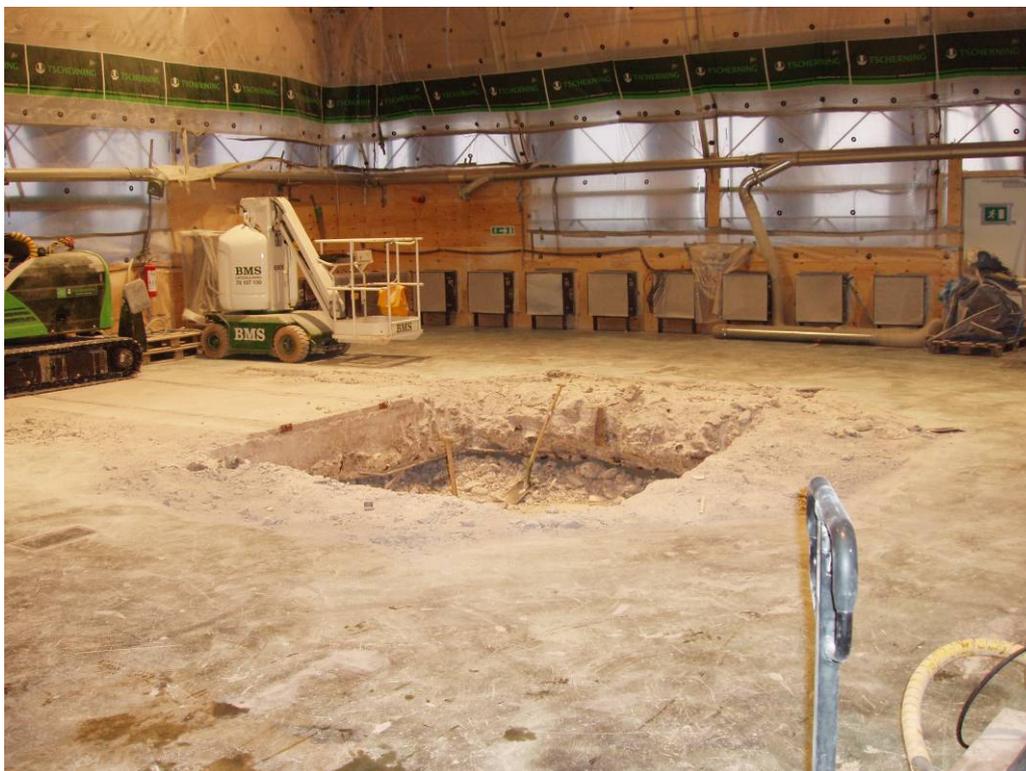
Figure 67. The reactor has been removed. At the back is the southern tent wall with extraction units ("environmental boxes").

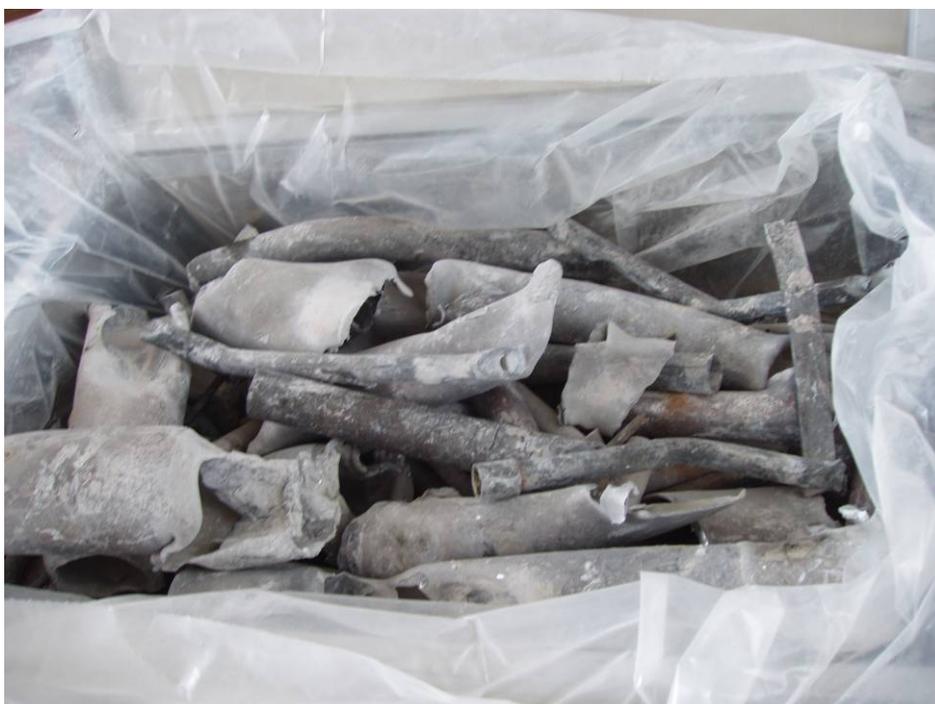
Figure 70. Cast-in pipe sections from the concrete structure removed for further checks.

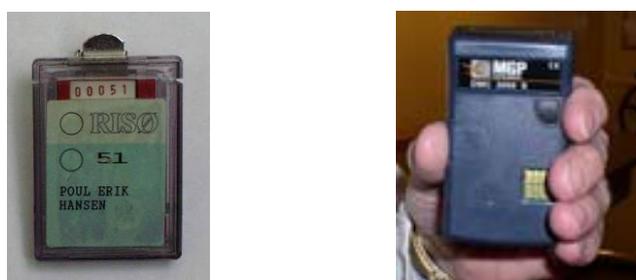
Figure 73. TL dosimeter and electronic dosimeter
